# ANALYSIS OF THERMAL CRACKS IN CONCRETE GRAVITY DAM SPILLWAY AND CONSTRUCTION CONTROLS

S. AOYAMA, T. HIRATSUKA AND N. YAMASHITA  
SHIMIZU Corporation, Japan

This is a new concrete gravity dam under construction inland in the Chugoku region in Japan, where the minimum winter temperature reaches  $-6^{\circ}\text{C}$ . Prior to commencement of construction 3-dimensional temperature stress analysis of the dam body was carried out to identify the parts where there was a risk of thermal cracks, and construction is proceeding while taking measures to reduce the occurrence of cracks. However, during construction, cracks occurred unexpectedly in the spillway at mid elevation, near the position of installation of an orifice pipe of spillway. This paper describes the measures for reduction of cracks based on the initial analysis, the analysis performed after the occurrence of cracks, and the countermeasures taken.

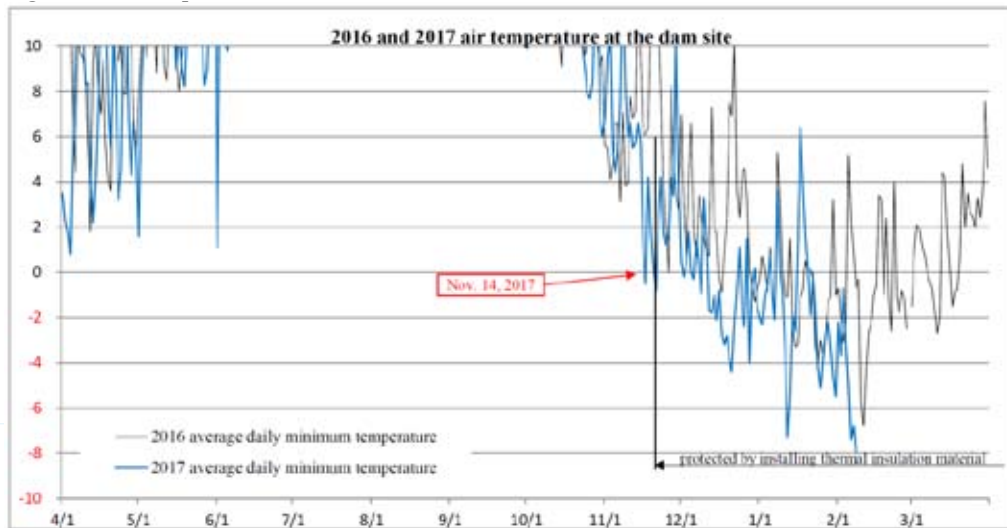
Fig. 7 : Minimum air temperature in 2016 and 2017 at the dam site

15 year average air temperature and 2017 air temperature at the dam site is as shown Figure 6. These cracks occurred on the surface at which placement had been stopped for 1.5 months, it occurred on November 14, 2017, when there was an unprecedented sudden drop in air temperature, and it extended downwards from the EL 125.0 m construction joint surface. Therefore, it is considered that the cause was thermal cracks due to internal constraint as a result of cooling the construction joint surface for a long period of time. To verify this a temperature stress analysis was performed inputting the actual air temperatures, actual placement temperature, and measured internal temperatures, and the occurrence of cracks was reproduced. Figure 7 shows a comparison of 2016 and 2017 minimum temperatures. In 2016, a low elevation spillway (conduit spillway) had been constructed in an adjacent block, and cracks had been prevented. However, temperature suddenly dropped in 2017 compared to 2016 before protection by installing thermal insulation material, and some cracks occurred.

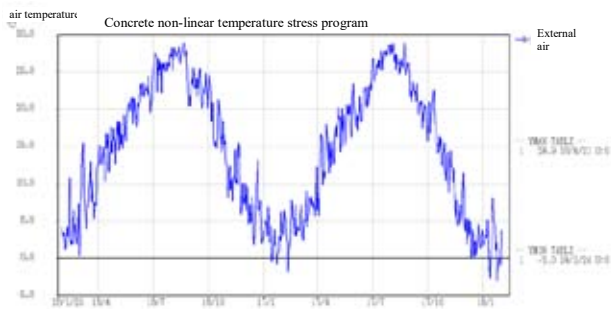
Fig. 8 : Measured external air temperature ata

The model from the previous analysis was used, and the measured values of external air temperature, concrete placement temperature, and concrete temperature were used. The measured temperatures used were as shown in Figures 8-9.

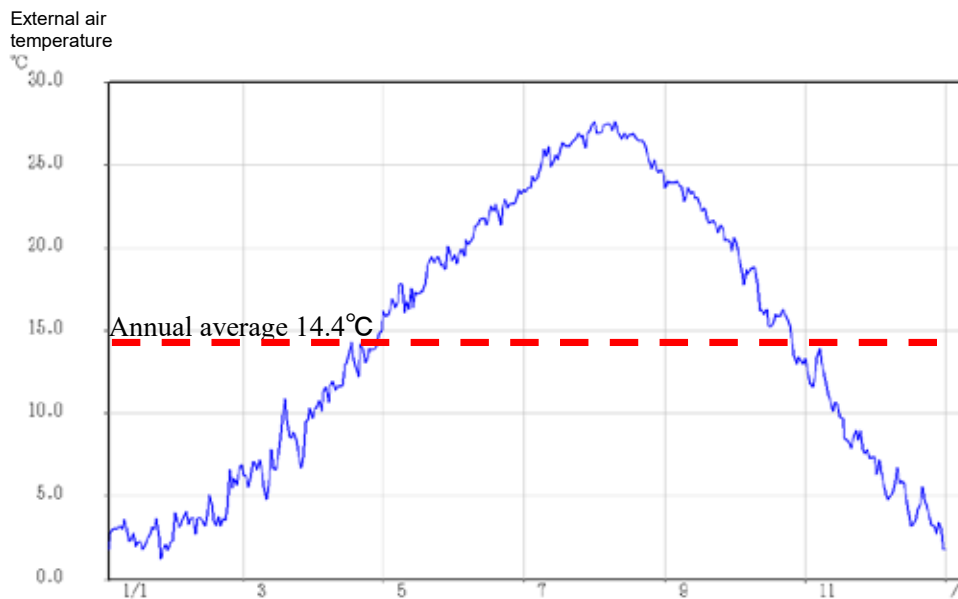
Figure 14. Daily average air temperatures (10 years average)

\* that the final stable temperature is the annual average temperature (see Figure 14).
