REHABILITATION AND STRENGTHENING OF THE DAMAGED DIVIDE WALLS AND DOWNSTREAM FLOOR OF DURGAPUR BARRAGE OVER RIVER DAMODAR AT BLOCK & P.S.- BARJOR A, DIST- BANKURA, WEST BENGAL

RAJESH D PANDEY AND SOUMYADIP PRAMANIK

Damodar Valley Corporation

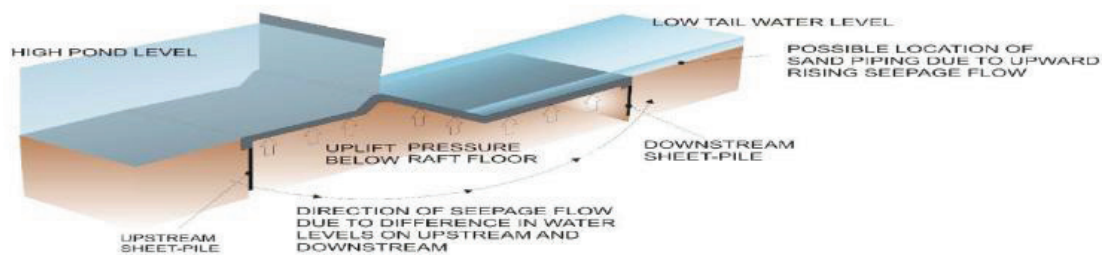
FIGURE 1. Effect of sub-surface flow below barrage floor

Piping is an erosion mechanism which is very relevant for river barrages. Since there is always a differential head between upstream & downstream, water is constantly moving from upstream to downstream from under the base of weir. The under-seepage of such structures in soils sensitive to erosion (e.g. fine-grained, but non-cohesive soils like fine or medium sand) can lead to the development of a pipe, in which soil material is transported. With sufficient hydraulic gradients, the pipe development progresses from the downstream to the upstream side. At the end of this process the total failure of the barrage or dam occurs.

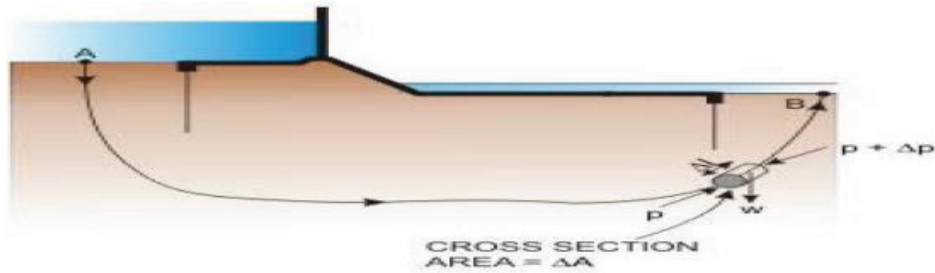
At the exit end, where the stream line meets the river bed surface (B in below Fig.), the seepage force is directed vertically upwards and against the weight of the volume of solid held in the soil. If the seepage force is great enough, it would cause sand-boiling, with the ejection of sand particles causing creation of pipe-like voids through the river bed, on the other hand, the river bed particles at the entry point (A in below Fig.) do not face such a problem, since both the seepage force and the particle weight are both directed vertically downward.

To provide safety against piping-failure at the exit end, the submerged weight (w) of the solid should be at least equal to the seepage force.

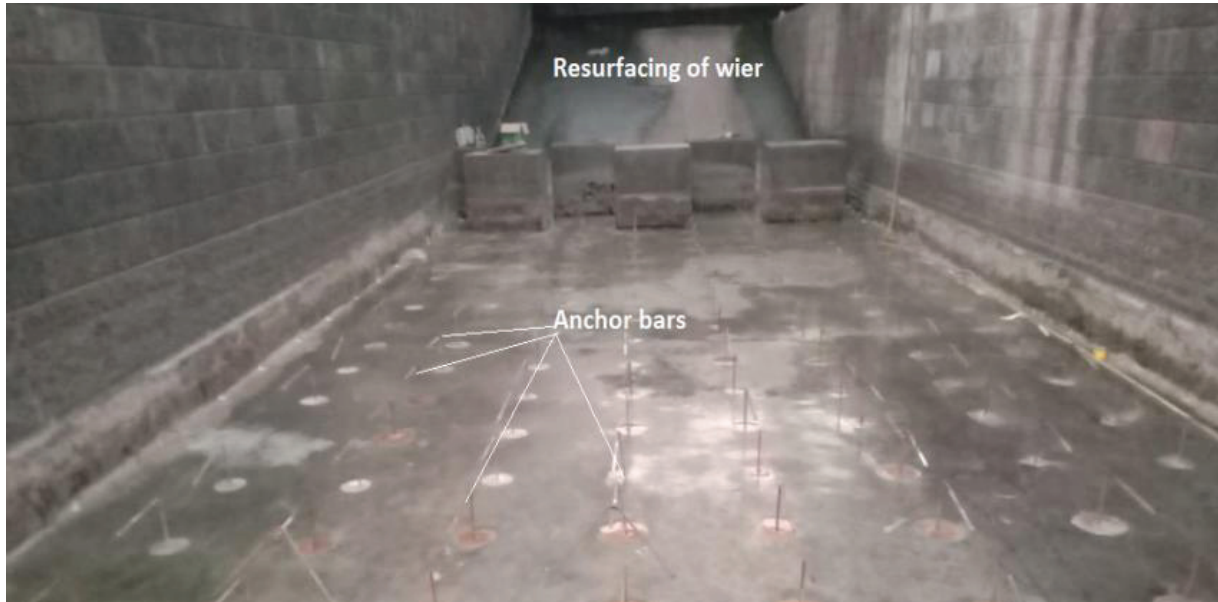
- There are cracks of width varies from 2 mm to 12 mm found in major portion of the gate piers and in the weir section.
- Honeycombs and cavities upto 5-15 mm depth are found in few areas in the gate piers and in the weir section.
- Few suction and leakage points are also observed in the structure.

1. Sealing of cracks in the weir section and in existing floor with cementitious and epoxy material
2. Pressure grouting through nozzles in the weir section and in existing floor with cementitious and epoxy material
3. Filling and sealing of cracks in partition and divide walls with micro-concrete.
4. Re-surfacing of weir section with abrasive resistant impermeable UV resistant High Performance Fibre reinforced polymer modified pre batched cementitious repair mortar of CE certified and conforming to EN: 1504-3-R4.
