ICOLD Symposium on Sustainable Development of Dams and River Basins, 24th - 27th February, 2021, New Delhi

AN OVERVIEW ON SEEPAGE INVESTIGATION DURING IMPOUNDING BY INSTRUMENTATION DATA – A CASE STUDY

The Cheragh-vays dam is located in the north-western of Iran at Kurdistan province, and is rock-fill dam with 62 m in height, 30 m curtain final depth. The first filling phase of the reservoir started on 2017 May. In This paper, detailed attitude on grouted curtain data in terms of performance has analyzed with respect to instrumentation data which is including dam foundation piezometer, observation wells, and V-notch, during impounding. Besides, conditions of the dam foundation geoengineering, relationship of any probable seepage media by the cement injected data on curtain grout holes in the course of construction is analyzed briefly.

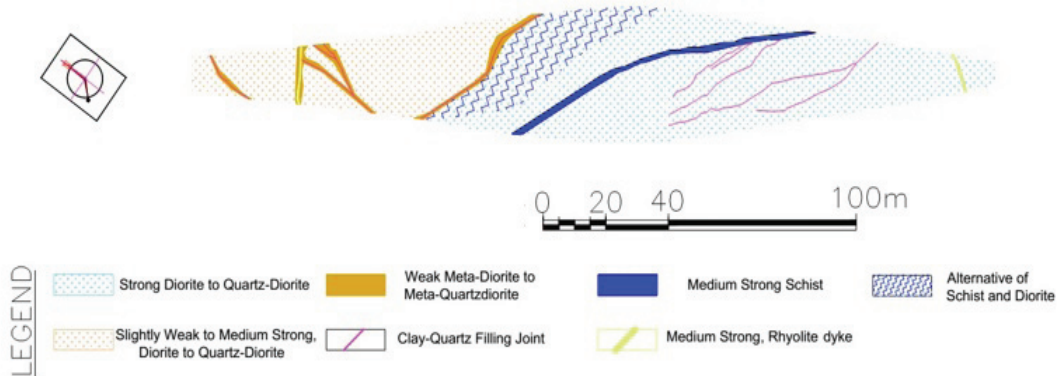
Figure 1 : Geological plan view of clay core foundation (MGCE, 2016).

The Cheragh-vays dam is located in Sanandaj-Sirjan tectonic zone of Iran. The dam foundation consists of diorite to quartz-diorite rocks with sub-vertical rhyolite dikes, and alternative seams of schist in left abutment as affected of tectonic force (figure1). Hydrothermal fluid zones were extended from the upstream of the dam reservoir to the left abutment due to hydrothermal quartz injection into the structural joints especially in schist formations. Hydrothermal phenomenon effected zone on the dam foundation was much less than the reservoir. Clay in-filled joints are extended in dam foundation up to 8 meters in depth (MGCE. 2016).

Water pressure test results during implementation phase decelerated that clay in-filled joints are capable to wash-out potential. Special (pressure) washing is used before cement injection for wash out of weak clay infilling which there were in the rock foundation joints aligned dam curtain (see Fig.2), (Hafezqurn, 2017).

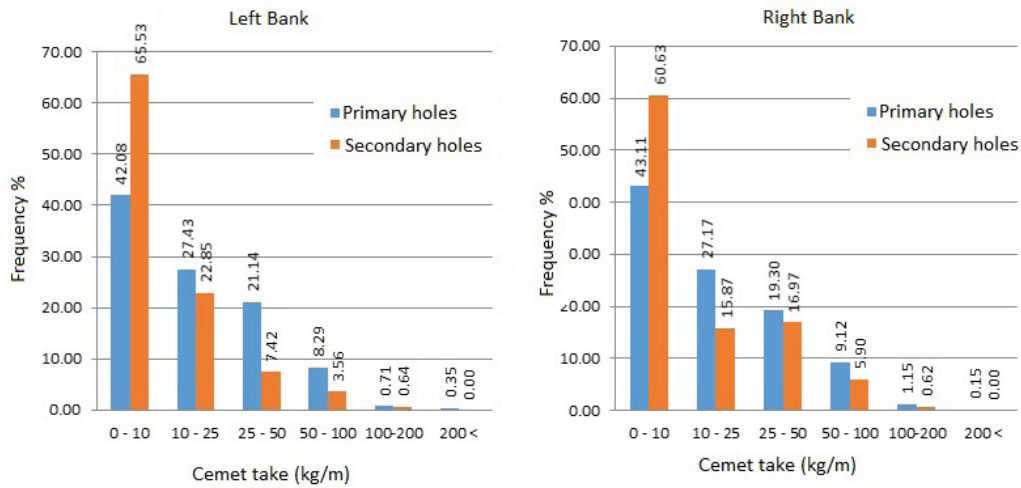
Figure 3 : Consolidation grouting results for primary and secondary boreholes (MGCE, 2016).

Consolidation grouting has been done to improve geotechnical parameters and thereby increase the bearing capacity of a part of the rock mass that is damaged by blasting operation and weak shallow rock mass. Consolidated grouting of Cherag-vays dam is designed as a triangular grid with 2 * 2 m borehole spacing and a final depth of 10 m. Type II micro-fine Portland cement (Blaine number > 5000 gr/cm²) was used for consolidation grouting. Consolidated grouting started with a water-to-cement ratio of 1:1 by weight and finally continued in highly grout-able stages to a ratio of 0.5. Superplasticizer has been added to the grout mix to increase the mobility and penetrability of the slurry at a rate of 0.4 to 0.6 percentage of cement weight. Figure 3 shows the results of consolidation grouting in primary and secondary boreholes for the dam banks.

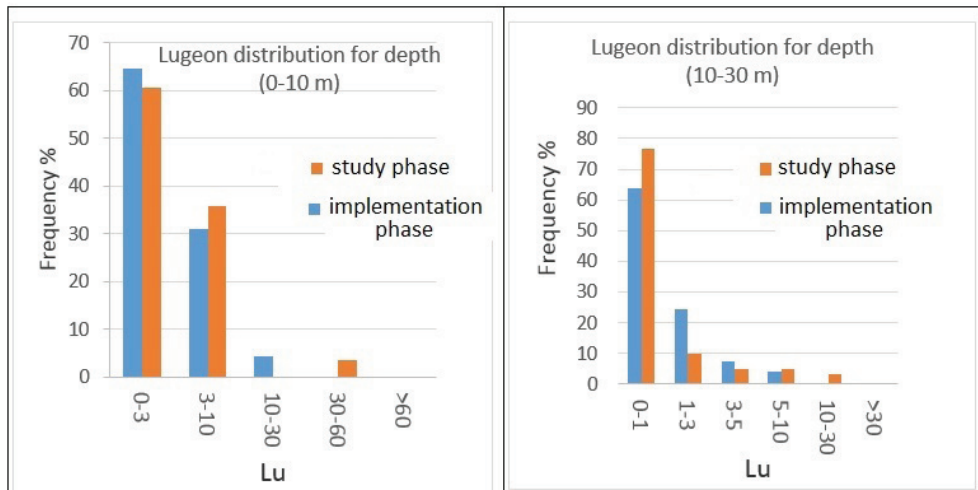
Figure 4 : Lugeon distribution in study and implementation phases for curtain grouting (MGCE, 2016).

Curtain grout is generally installed to reduce seepage through dam foundation, decrease uplift pressure and control the foundation. Due to the presence of clay-filling joints, the curtain grouting of the dam carried out with high degree of control and monitoring in order to prevent long-term erosion of the foundation. According to Houlsby’s (1990) criterion, the sealing level of the dam should be below three Lugeons. Figure 4 shows the permeability distribution in study and implementation phases for curtain holes.

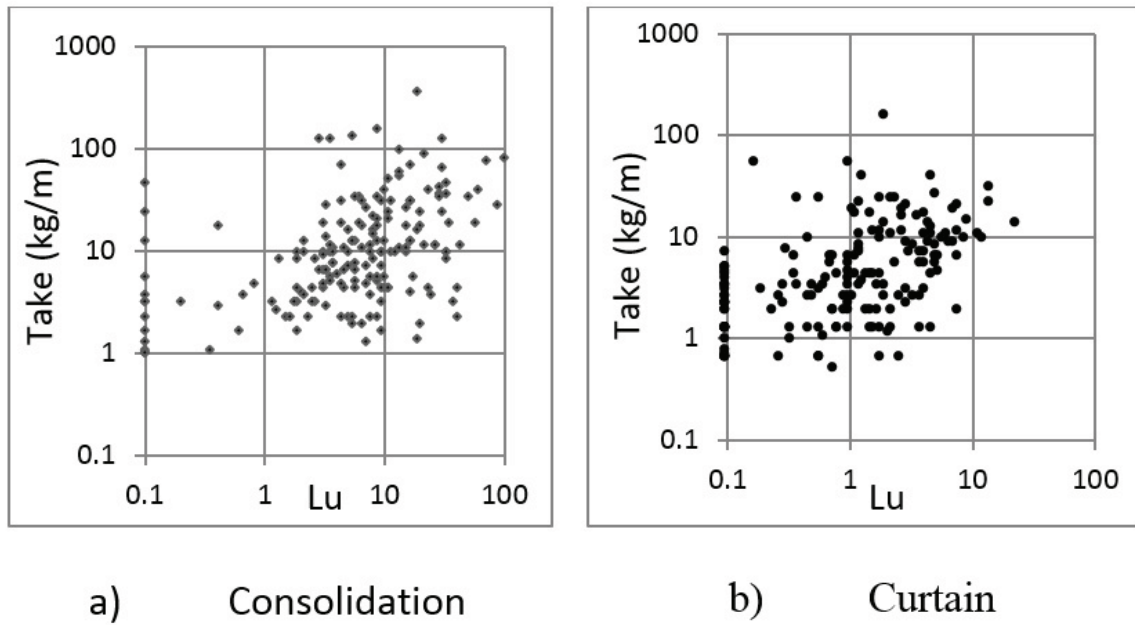
Figure 5 : The relation between permeability and cement take in consolidation and curtain grouting (MGCE, 2016).

The curtain of the Cheragh-vays dam is installed in the central row of the consolidation grout holes. Due to the low permeability of the site, a final depth of the grout holes was 15-30 m from quaternary to primary holes. The spacing of the first series of curtain holes (Series A) is 16 m. curtain grouting done by “split-spacing” method because it has shown its effectiveness in practice. One of the main reasons for using this method is the inability of grouting science to estimate the slurry penetration radius. The split-spacing method is actually an inverse method for estimating the injection radius Figure 5 shows the relationship between permeability and cement take for consolidation and curtain grouting. As can be seen, the permeability in the grout curtain is generally below 10 Lugeon. This is due to the effect of consolidation grouting on permeability reduction for depths less than 10 m as well as permeability reduction with depth along grout curtain Fig. 2 shows the permeability and cement take results of curtain control boreholes. According to the figure, more than 93% of the permeability values are below 3 Lu and more than 98% of cement take values are below 25 kg / m.

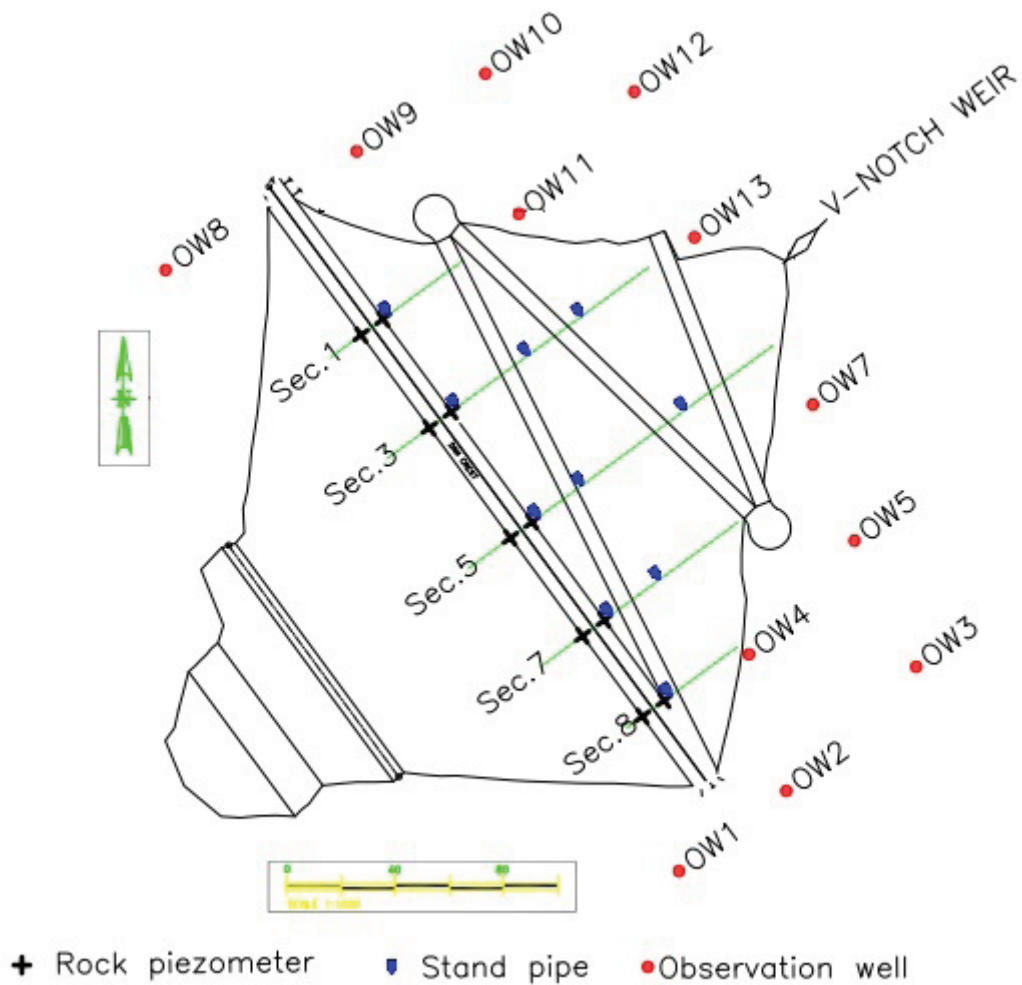
Figure 7 : General plan view of dam instrumentation sections.

Figure 7 shows the plan view of the cheragh-vays instrumentation section. In this figure, only the rock foundation piezometer, rock stand-pipe, observation wells, and V-notch, which are related to the estimation of dam seepage, are shown. For each section, two rock piezometers are installed 5 m upstream and downstream of the grout curtain respectively, at a depth of 10 m beneath the foundation surface. These piezometers are used to evaluate the grout curtain performance. Adjacent to the downstream piezometer, a twin stand-pipe is installed in two different levels to evaluate the accuracy of rock piezometers. Other standpipes are installed downstream of the clay core along these sections. Observation wells are installed for recording groundwater changes. These tools actually complement the rock piezometers and standpipes.
