ICOLD Symposium on Sustainable Development of Dams and River Basins, 24th - 27th February, 2021, New Delhi

INDIAN EXPERIENCE IN FLEXIBLE GEOMEMBRANE FOR WATERTIGHTNESS OF AGEING DAMS

Carpi India, Chennai, India

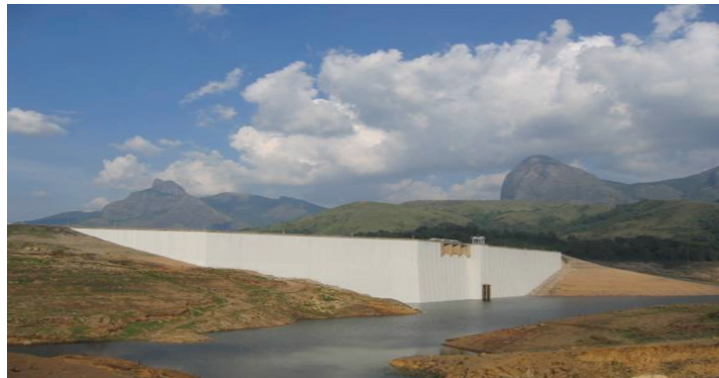
The client has confirmed "the results that the leakage of the order of 30,000 litres/minute has been reduced to 100 litres/minute. The overall cost has been kept within the announced limits and the entire work was completed ahead of the time allowing earlier generation of power house".

The result of the geocomposite installation at Kadampara dam in 2018/2019 is still sound with the leakage still around the same levels. The first geomembrane project has more than satisfied the client in terms of the results, and since its installation the dam is now filled up to the FRL (Full Reservoir Level) thereby allowing full generation power of 400 MW, which was not possible before geomembrane works as the dam was operated at nearly 10 metre below FRL.

Figure 4 : Kadampara dam after installation of the geomembrane system
