ICOLD Symposium on Sustainable Development of Dams and River Basins, 24th - 27th February, 2021, New Delhi

DAM BREAK ACCIDENT AND RESULTING SEDIMENT MANAGEMENT AT DOWNSTREAM DAMS IN LAO PDR - HIGHLY TURBID FLOOD-FLOW AND SEDIMENT FLUSHING AT NAN NGIEP 1 HYDROPOWER PROJECT –

T. TABUCHI

Nam Ngiep 1 Power Company Limited, Bolikhamxay, Lao PDR

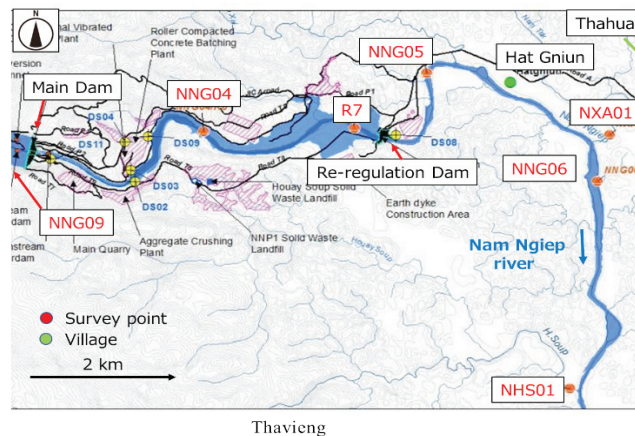
Figure 5. Location of water quality testing

The turbid water reached the NNP1 7 hours later from the dam break. While the NNP1 measures the water level two times per day, the increase in the water level due to the dam break was slight, 14 cm. The water quality of the NNP River was tested at several points as shown in Figure 5. As seen in the time series of Total Suspended Solids (TSS), an extremely high TSS was observed upstream of the main dam NNG09 (See Fig. 5). It was 1,000 times TSS (125,172 mg/liter) as much as the past measured maximum TSS. The high TSS continued for five days after the dam break. The high TSS was also observed in the re-regulation dam reservoir NNG04, which is 4 km downstream from the main dam, however, it was one-hundredth of that measured at the main dam. At that time the main dam was under construction and the turbid water flowed through the diversion tunnel of the main dam. The TSS measured downstream of the re-regulation dam NNG05 was one-fortieth of that at the main dam NNG09 and high TSS continued for rather long time. It is assumed that highly turbid water flowed quickly around the main dam where the narrow valley is formed and the Suspended Substance (SS) settled in the re-regulation dam reservoir, of which capacity is 7,700,000 m³ at a high water level 179 m. It means the re-regulation dam reservoir had a role of diluting the turbid water. The time series of the Dissolved Oxygen (DO) is shown in Figure 7. The minimum DO was observed on 12th September 2017. The DO was 4.93 mg/liter lower than 6 mg/L, which is a criterion of the NNP1 for maintaining habitat. A large amount of fish was died due to the highly turbid water. It was assumed that the direct cause of death of fish was not DO but clogging of the gill due to the high density clay and silt in the water.

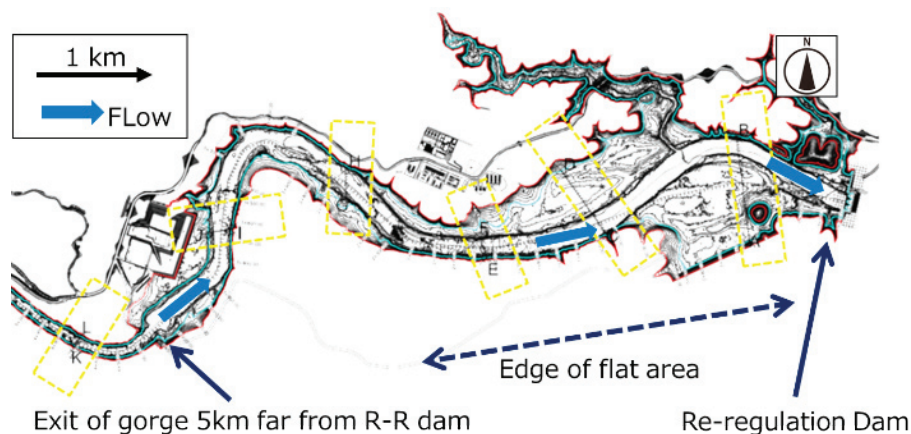
Figure 11 : Plan of re-regulation dam reservoir

The initial impounding of the main dam started in May 2018. During the initial impounding, the environmental flow release was planned by using the stored water in the re-regulation dam reservoir. The environmental flow requires $5.5 \text{ m}^3/\text{s}$ during the initial impounding, which is equivalent to specific index of $0.15 \text{ m}^3/\text{s}/100 \text{ km}^2$. It was feared that a large amount of the clay and the silt accumulated in the re-regulation dam reservoir got anaerobic and highly turbid water might be released through a small channel being formed on the surface of the sedimentation in the re-regulation dam reservoir due to a slight volume of the environmental flow release. To solve this issue, sediment flushing before initial impounding was planned by using a gate installed at the re-regulation dam, which is used for discharging the environmental flow of $27 \text{ m}^3/\text{s}$ during operation period according to the concession agreement with the Lao Government. The discharge capacity of the gate is designed to be $213 \text{ m}^3/\text{s}$. The plan and profile of the re-regulation dam reservoir are shown in Figure 11 and Figure 12. The width of the river varies around 50 m to 100 m and sedimentation was mainly accumulated at the flat area 2.5 km upstream from the re-regulation dam reservoir. The NNP1 implemented the sediment flushing in November 2017 when the inflow was still abundant in the dry season 2017 to 2018. At first, the reservoir water level was lowered in the initial three days by keeping $130 \text{ m}^3/\text{s}$ discharge from the gate. And then the sediment flushing was conducted in the middle three days by keeping the water level at the lowest with $100 \text{ m}^3/\text{s}$ discharge. Finally the reservoir water level was raised in the last three days with $70 \text{ m}^3/\text{s}$ discharge. By the way, before implementation, the program of the sediment flushing was informed to the residents through consultation meeting and finally approved by the Resettlement Management Committee of Bolikhamxay Province.

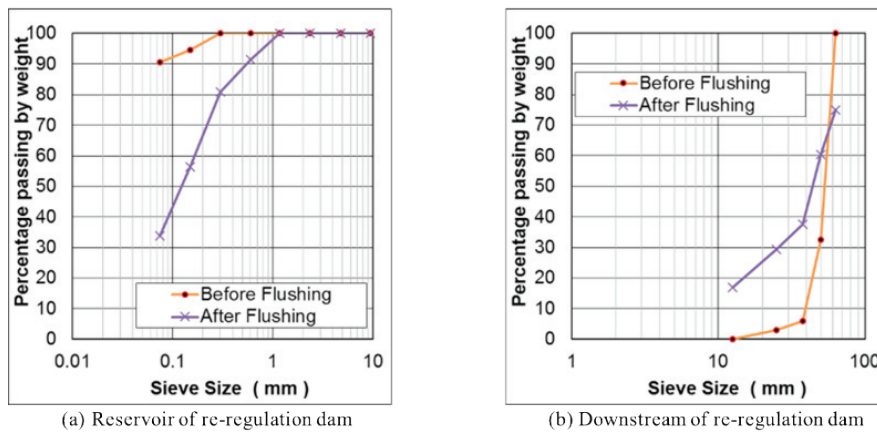
Figure 14 : Discharge plan of sediment flushing

By the sediment flushing, total 200,000 m³ sediment accumulated downstream area of the re-regulation dam reservoir was discharged. The particle size distribution of the sediment in the re-regulation dam reservoir collected before and after the sediment flushing is shown in Figure 14. The particle size distribution in the re-regulation dam reservoir became large by sediment flushing, since clay and silt were mainly flushed away. On the other hand, the particle size distribution downstream of the re-regulation dam became small. The gravel of which particle size around 10 mm increased downstream of the re-regulation dam, that is to say, gravel forming the riverbed in the re-regulation dam reservoir was also flushed away as well as clay and silt. A rapid of the original riverbed in the re-regulation dam reservoir is shown in Figure 15 and rather large size of stones existed. These materials were flushed away and accumulated around the tailrace of the re-regulation dam and the tailrace water level increased slightly.

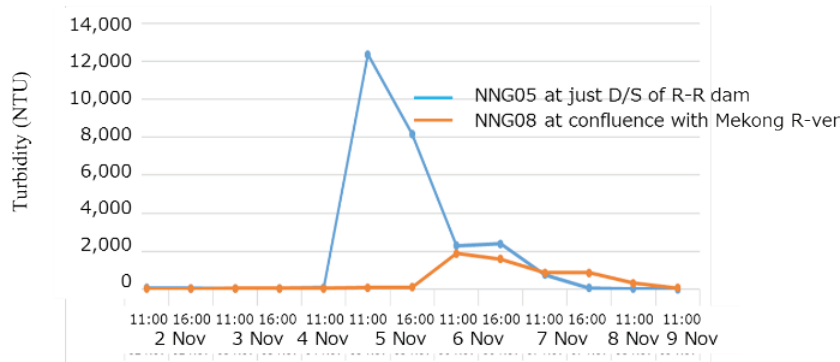
Figure 17. Time series of water level of the re-regulation dam reservoir

Time series of the reservoir water level of the re-regulation dam reservoir, turbidity (NTU), and TSS are shown in Figure 16, 17, and 18 respectively. The reservoir water level decreased to the minimum water level at midnight on 4th November 2017. The maximum TSS of 7,350 mg/L was observed at 7:00 of 5th November 2017 and the maximum turbidity of 12,370 NTU was observed at 11:00 of 5th November 2017. Though the exact time of the peak of them is not identified due to limitation of the water quality test during the night time, it is assumed that sediment flushing succeeded effectively when the reservoir water level got the minimum water level and the sediment flushing continued until the reservoir water level was raised to the full tank level on 7th November 2017. The turbidity downstream of the re-regulation dam decreased to the normal level on the same day. On the other hand, turbidity at the confluence of the Mekong River and the Nam Ngiep River (NNG08) continued high till 8th November 2019. The amount of dead fish during the sediment flushing along several kilometers downstream from the re-regulation dam was only 2 kg. Therefore the impact of the sediment flushing on the habitat was not significant. The photos of the reservoir before and after sediment flushing are shown in Figure 19. The riverbed appeared upstream right side of the reservoir, of which surface was covered with mainly the silt and the sand.
