INTERNATIONAL DAM SAFETY CONFERENCE

REHABILITATION OF *GARARDA* EARTHEN DAM

Authors: Randhir Kumar Choudhary, *Deputy Director*
Ashwani Kumar Verma, *Deputy Director*

Central Water Commission, New Delhi (India)

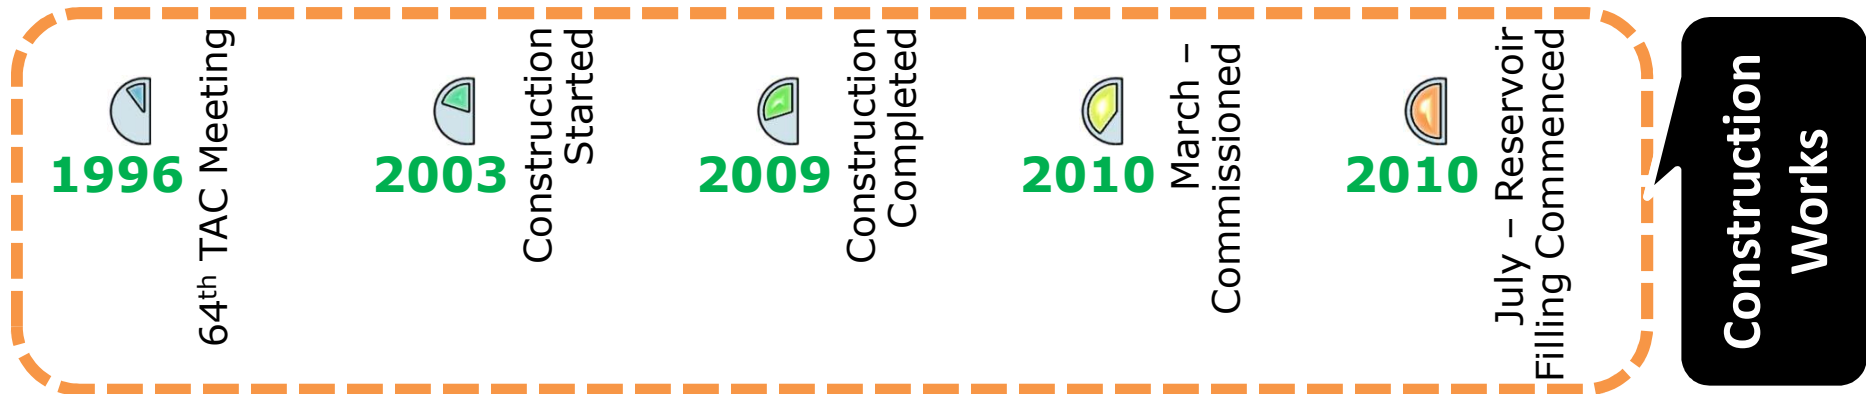
CHRONOLOGY

- ❑ On completion of the dam, the reservoir filling commenced on July 26, 2010.
- ❑ **Due to heavy rain the catchment area, the water level in the reservoir quickly rose up to EL 291 m (just 4 m below FRL)**
- ❑ Subsequently, on **August 15, 2010 at 4:30 am** –

the central portion of the dam across the Dungari River washed away from the closure section

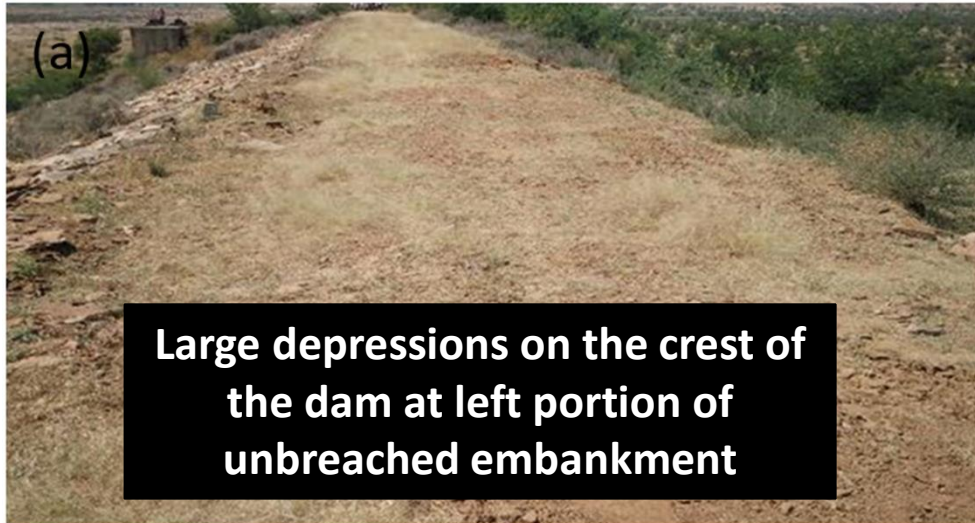
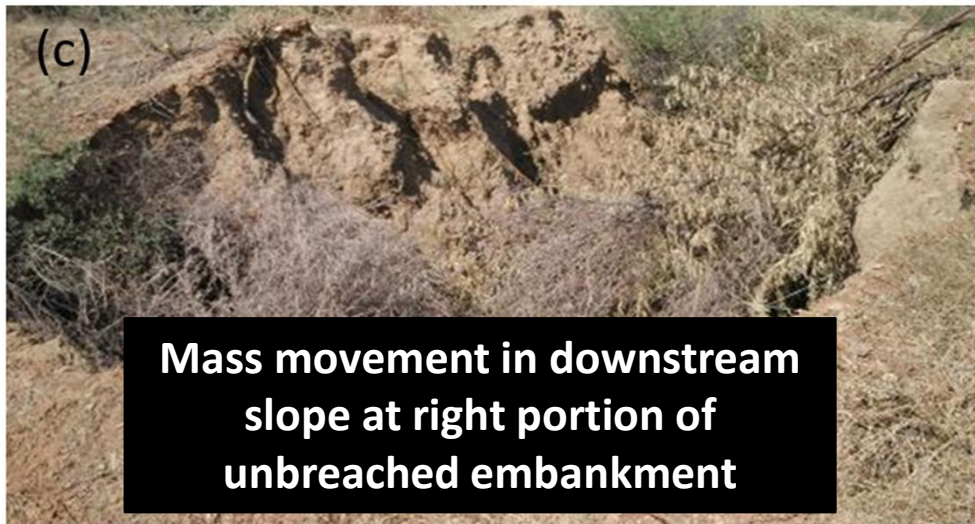
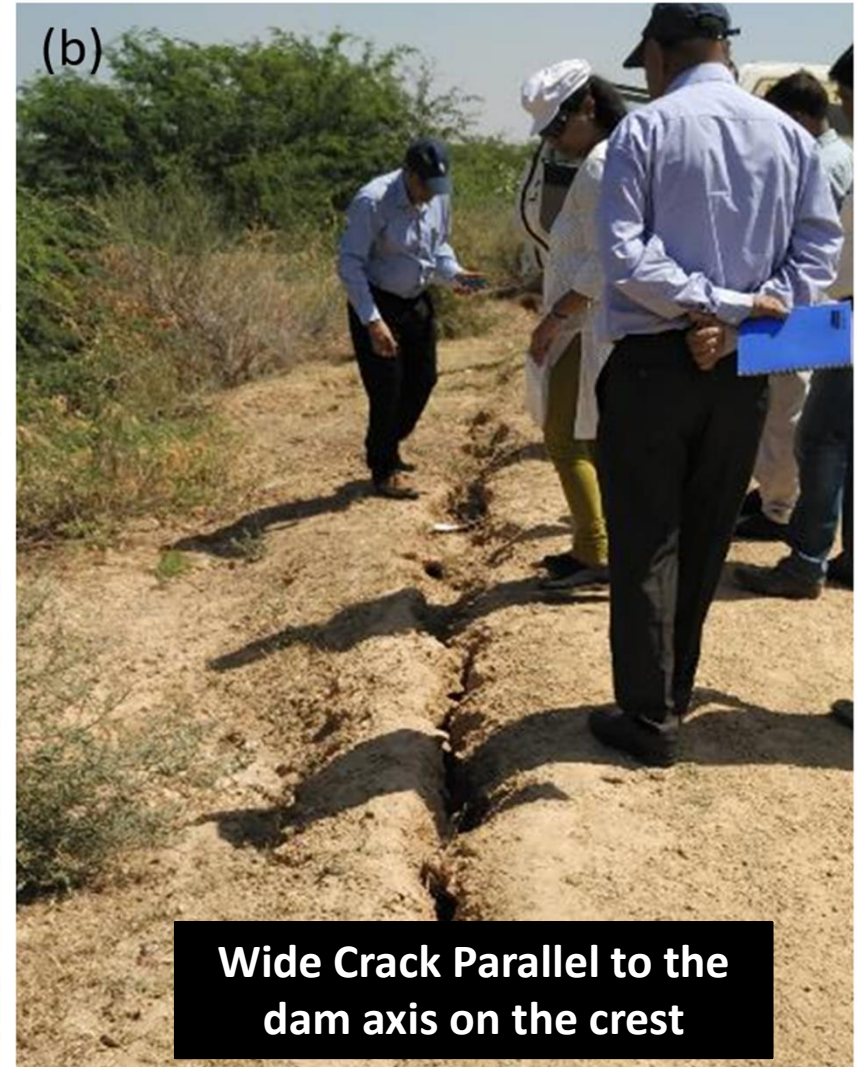
Deep rain cuts and gullies were observed on the D/S slope on entire dam body.

Localized slope failures were also found at some location on D/S slope.

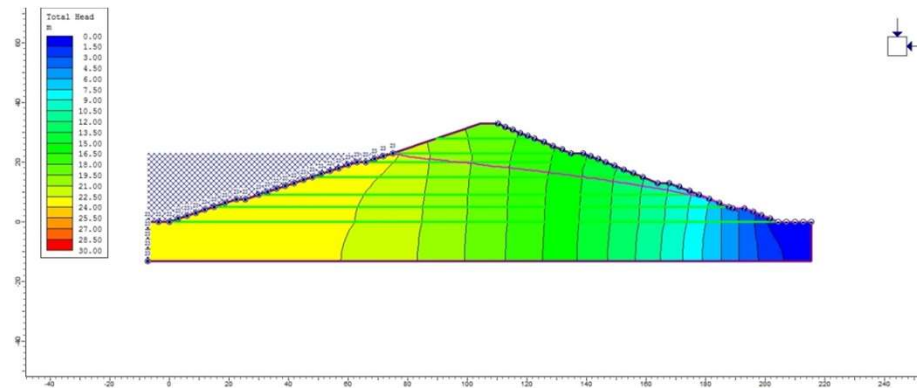
Seepage analysis is performed to estimate the phreatic line and hydraulic conditions

FE Analysis Results for Drawdown Conditions

- ✓ Further, during breach even existing dam section was subjected to sudden drawdown condition which has resulted in local slope failure in upstream face and settlements at the discrete location. The FEM analysis also depicts local slope failure near toe and first berm on the upstream slope.

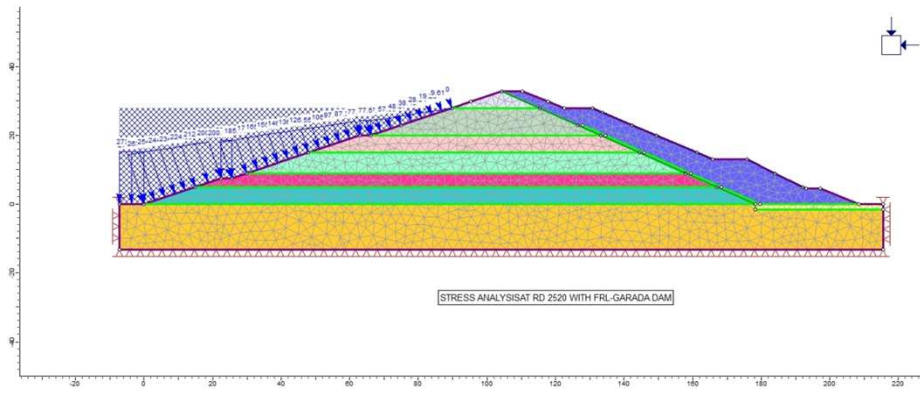
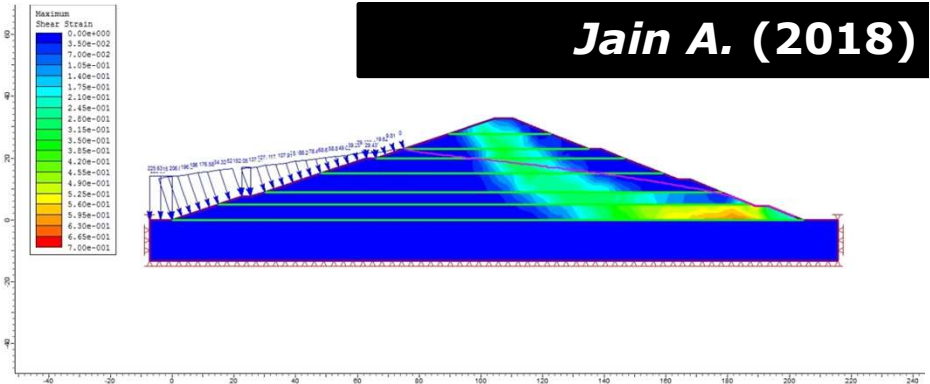
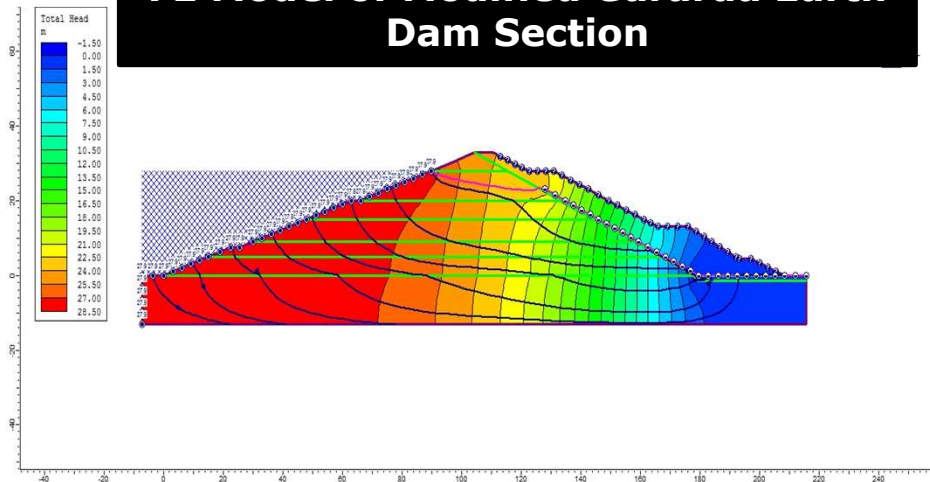
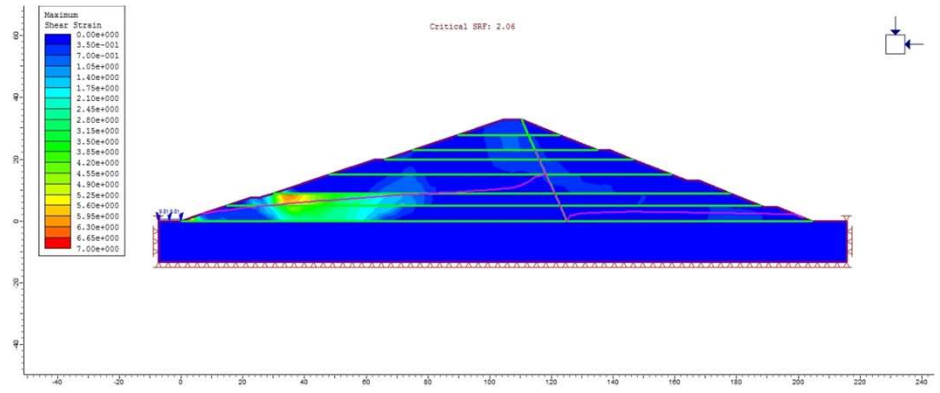
FE Model of Modified Gararda Earth Dam Section

FE Analysis Results of Steady State Seepage Conditions.

Seepage analysis is performed to estimate the phreatic line and hydraulic conditions

FE Analysis Results for Drawdown Conditions

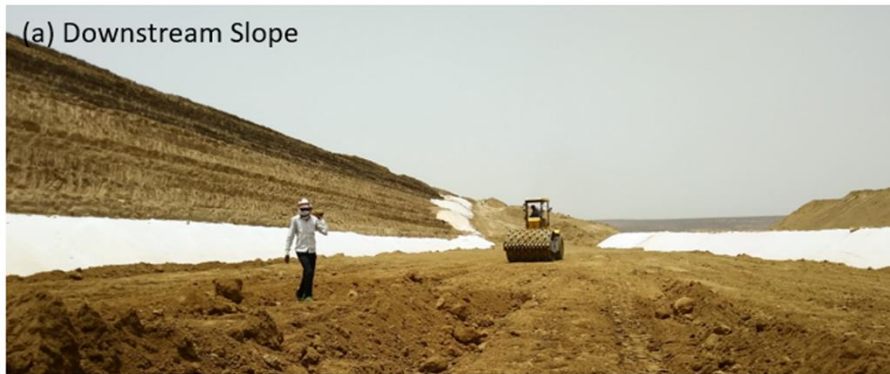
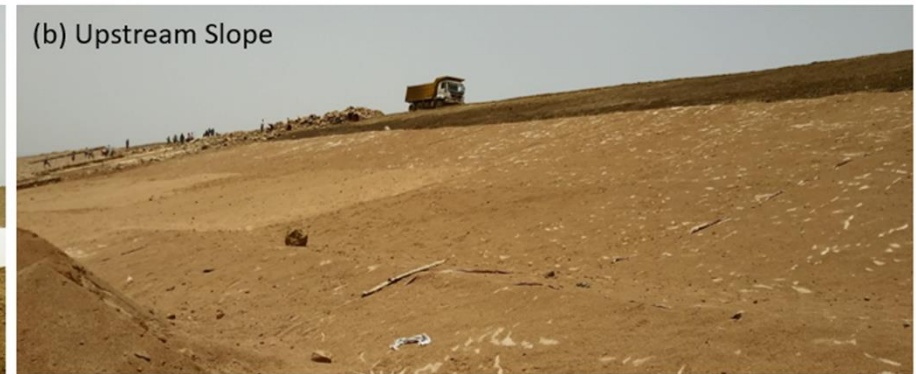
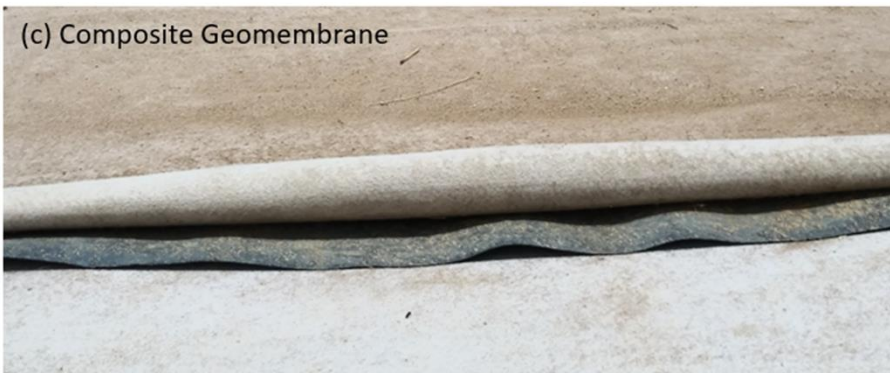
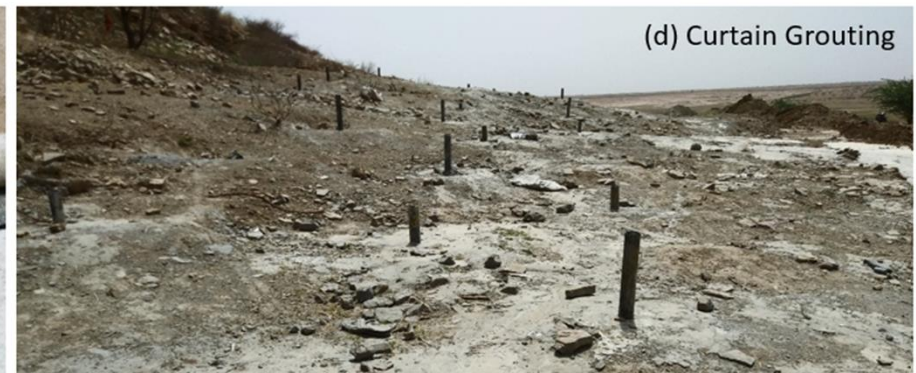
Rehabilitation Works at unbreached Sections

b) The cobble layer over which the unbreached section was founded

The portion of unbreached portion, founded over cobble layer, completely removed and laid as fresh dam section.
