## REPAIR & REHABILITATION OF SPILLWAY GLACIS USING STEEL LINER - CASE STUDIES OF DHAULIGANGA & TEESTA STAGE-V DAM

Rao Musharraf Ali Khan, Rajesh Kumar & Shankar Kumar  
NHPC Limited, Haryana, India

10-12 October 2022 at Jaipur, Rajasthan (India)

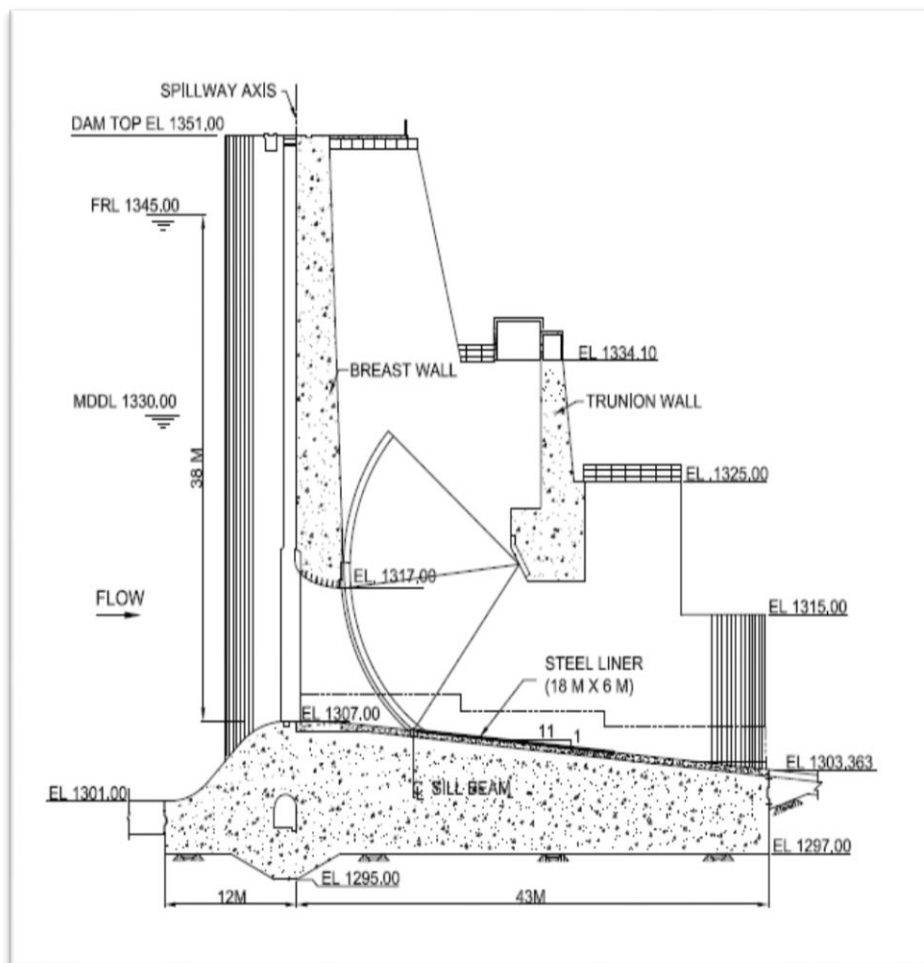
## DHAULIGANGA DAM SPILLWAY

<u>Spillway</u>	
Dam Type	CFRD
Head over crest	<b>38 m</b>
Avg. annual sedimentation load	<b>3 MCM</b>
Avg. Velocity	22-25 m/s
Boulder rolling	<b>Yes</b>
Gate size (B x H)	6m x 10m
Design Flood	<b>3210 m<sup>3</sup>/s</b>

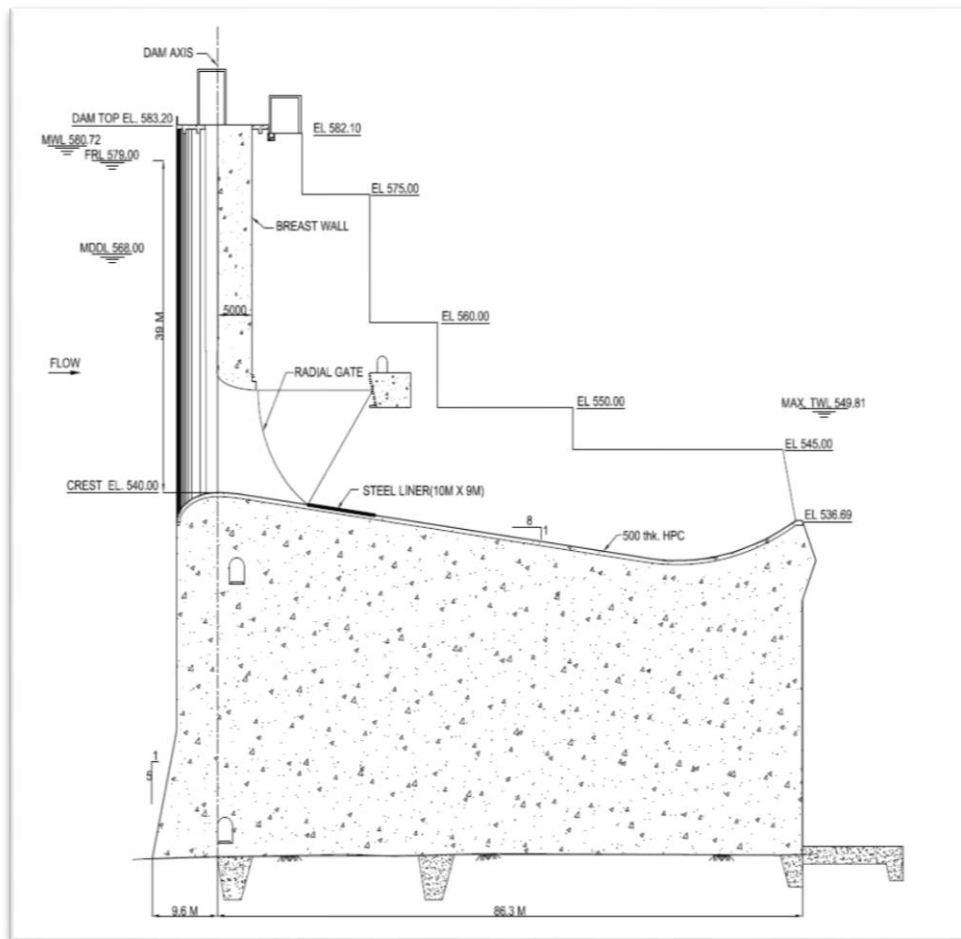
## TEESTA STAGE –V DAM SPILLWAY

Dam Type	Concrete Gravity
Head over crest	<b>39 m</b>
Avg. annual sedimentation load	<b>10 MCM</b>
Avg. Velocity	22.5 to 25 m/s
Boulder rolling	<b>Yes</b>
Gate size (B x H)	9m x 12m
Design Flood	<b>9500 m<sup>3</sup>/s</b>
