**HEAVY WATER INGRESS IN DEEP SEATED FOUNDATION GALLERIES OF OPERATIONAL DAMS  
ISSUES, CHALLENGES & REMEDIAL MEASURES- A CASE STUDY OF NTPC KOLDAM**

Vishal Kaushik, Jagat Singh Yadav & Dr. Anubhav  
NTPC KOLDAM, INDIA

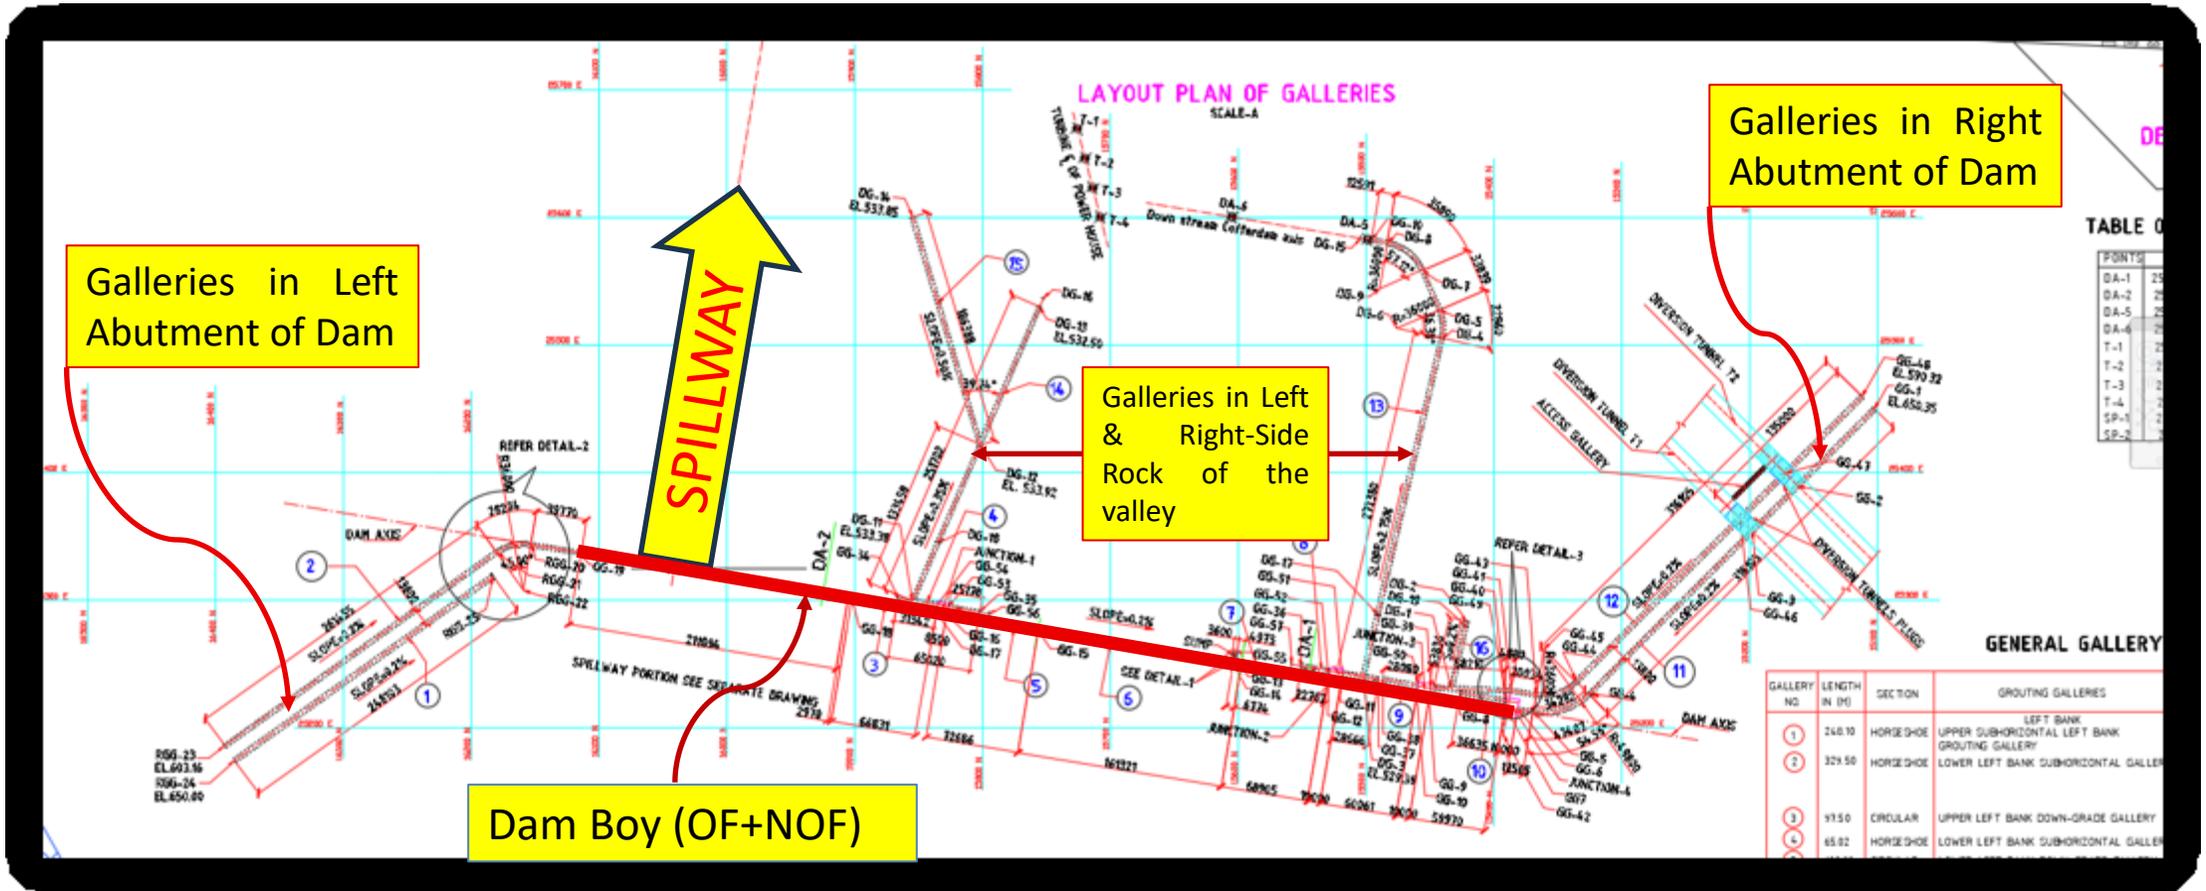
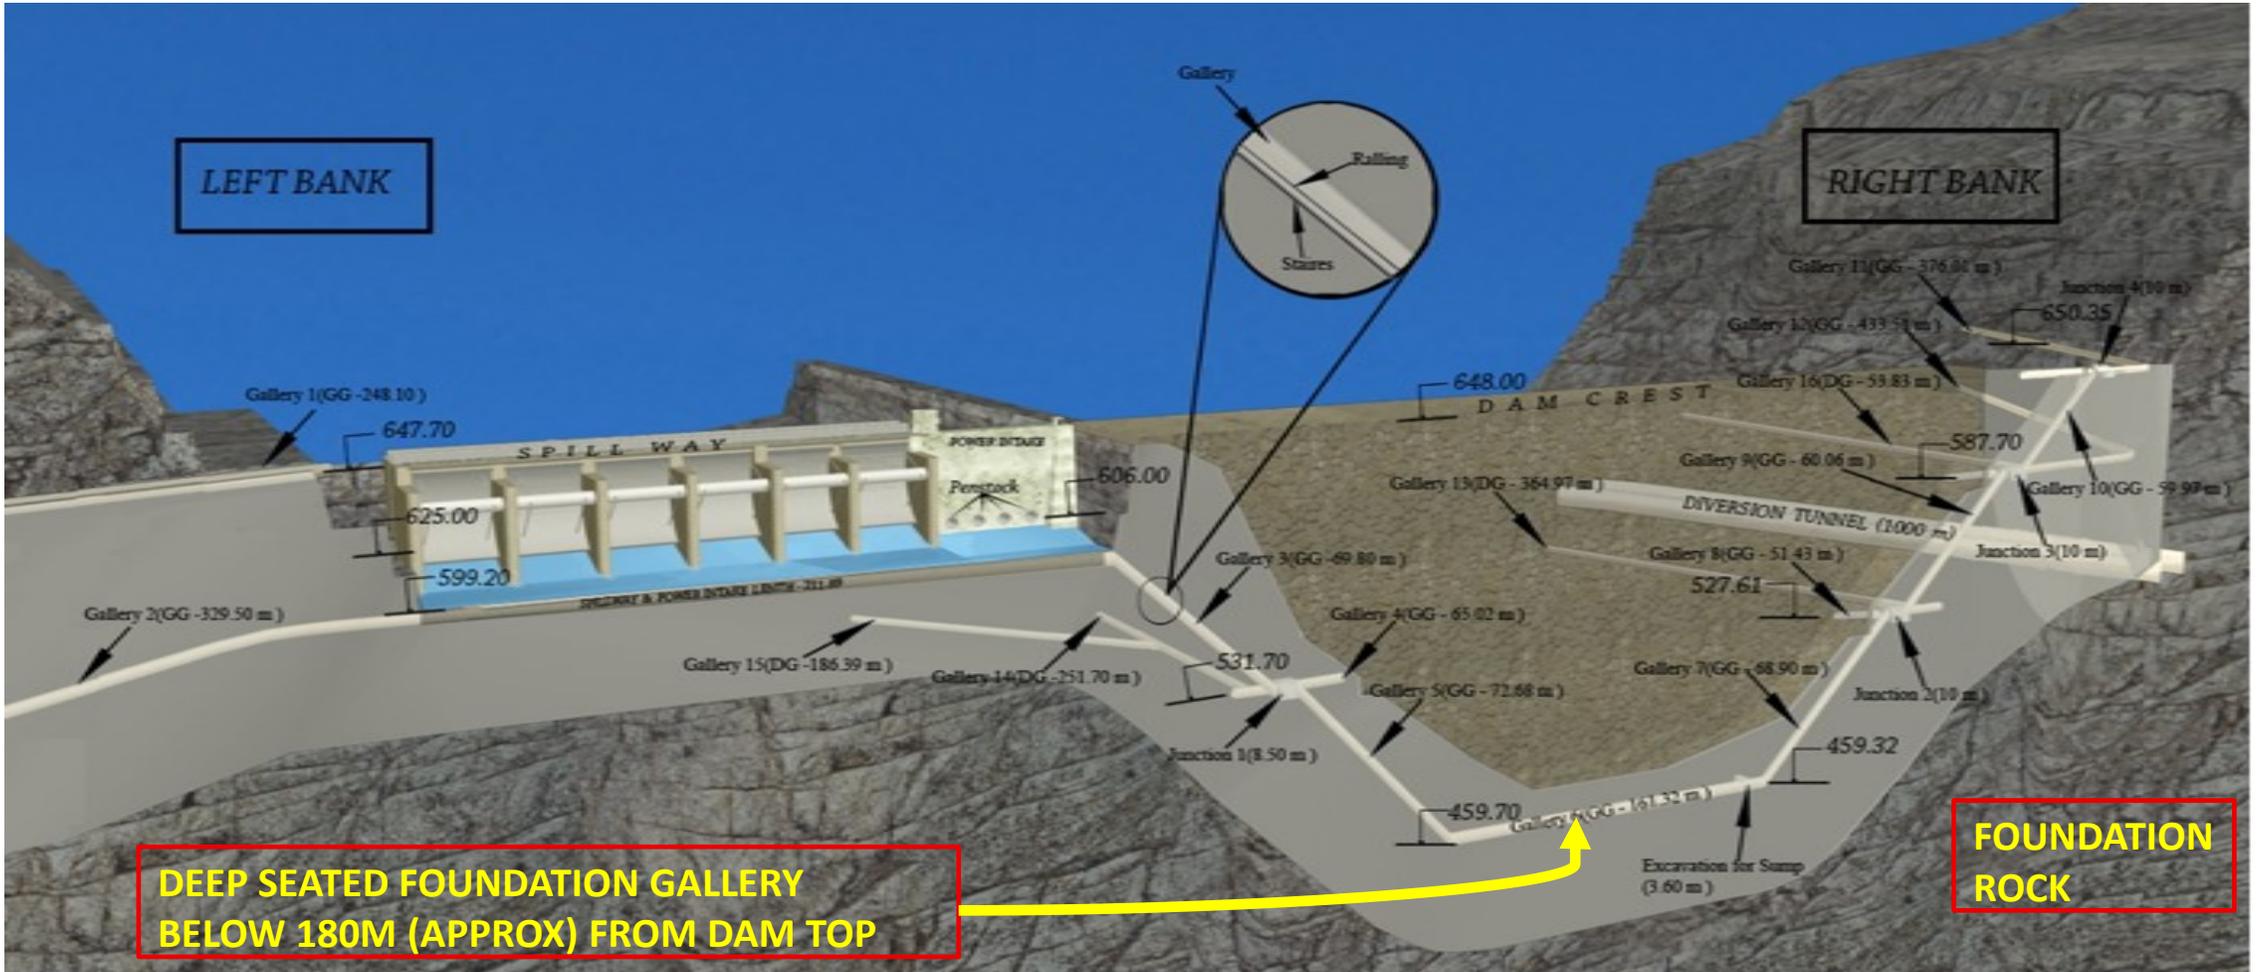
# LOCATION OF FDN GALLERY –WHERE LEAKAGE OCCURED

- ✓ Heavy water ingress in Dam foundation gallery was observed on 18.01.2025.
- ✓ This Gallery is concrete lined (Plain concrete), 3m finished diameter & 160m long .
- ✓ Water ingress was observed at RD 55M & 11 O'clock position, D/s side.
- ✓ Discharge measured was of the order of 330 to 350 lpm

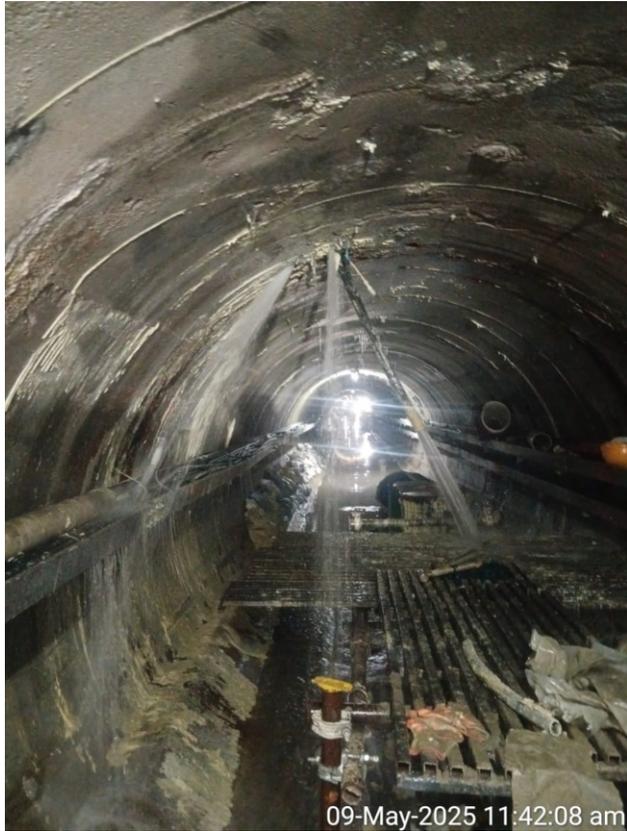
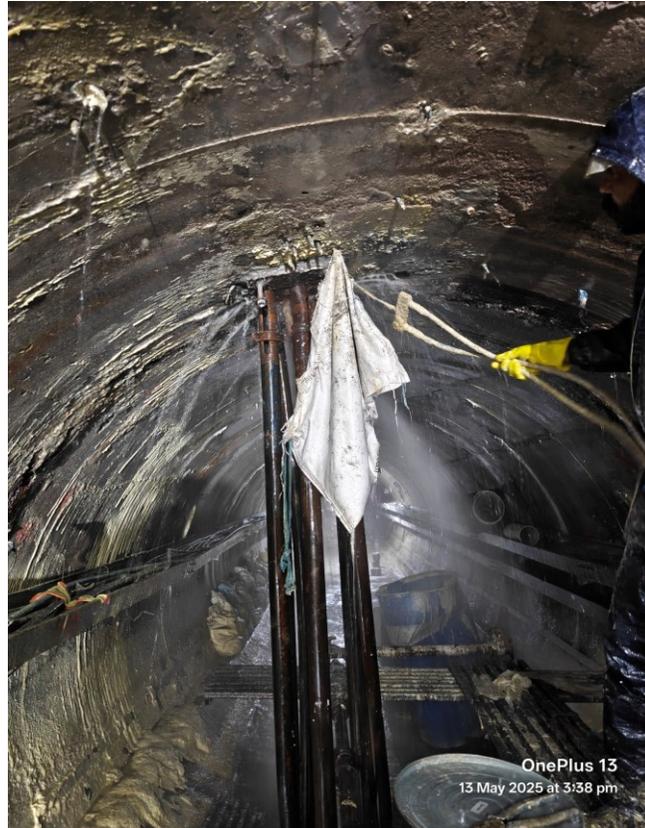
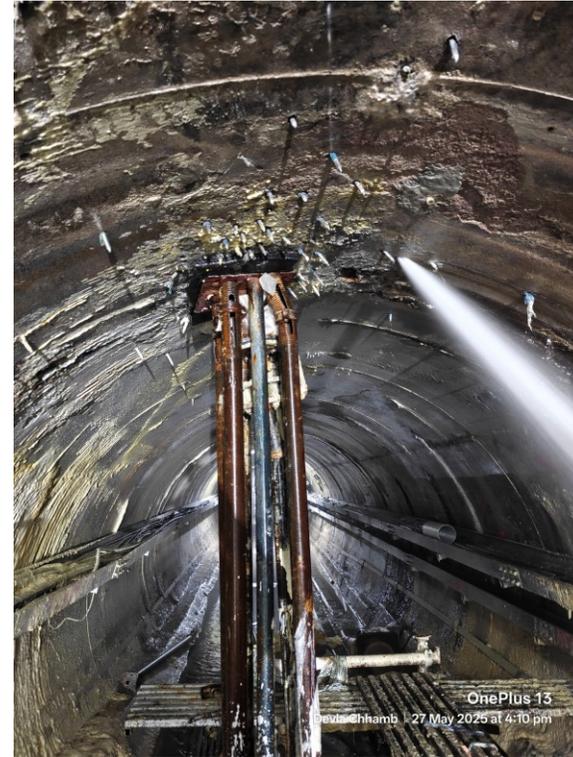
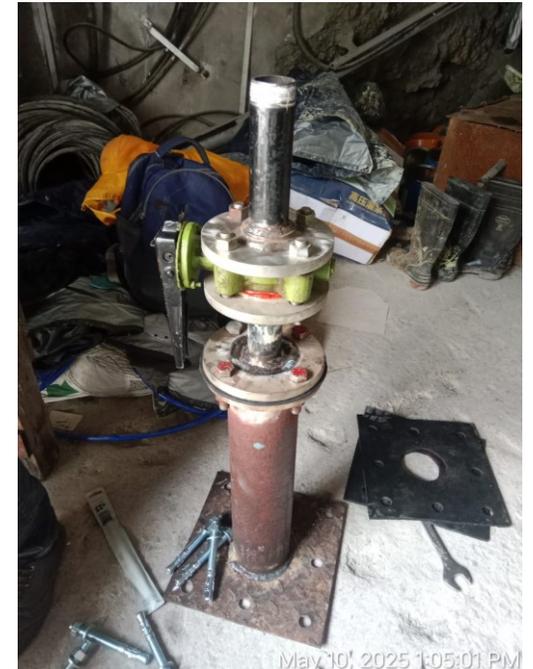
# SITE PICTURES DURING WORK

1. No response from packer agencies. And first attempt of site made packer got failed.
2. Hence, directly Grouting of area using was non-foaming compound was attempted. But it was not successful, as within no time that gout material was coming out due to flow of water etc.

3. Grouting expert was contacted to change the composition in view to change the setting time, and with revised grouting material, grouting was re-attempted. And some of the grouting could be done but leakage was not controlled.

5. Water was then channelized with the help of packer, and decided grouting was done.
6. After injecting adequate grout, water leakage stopped.
7. After that consolidation grouting using TAMPUR 116 non-foaming material & secondary drill holes, was done.

(1) Step-I : For arresting heavy water Leakage –Using TamPur 125 PU Resin with Foaming properties

non- Step-II : For treating further leakages, if observed - Using TamPur 116 PU Resin , foaming properties

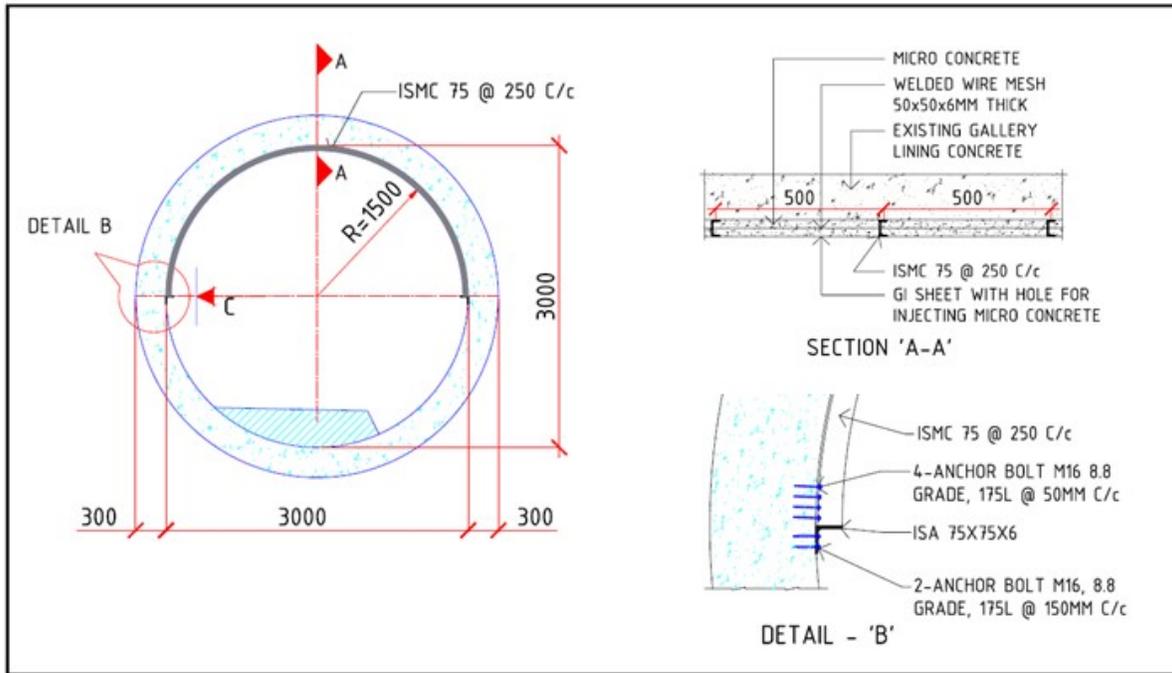
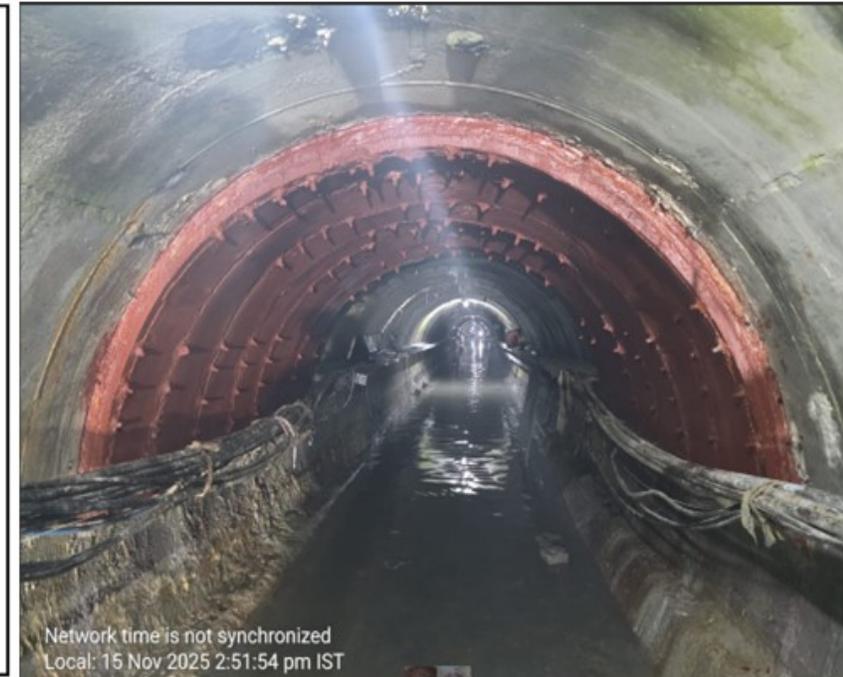
# STRENGTHENING OF TUNNEL LINING (OVERT PORTION)

Keeping in view the durability aspect of grouting and the structural health of tunnel overt at the affected location, following was also implemented as strengthening measures:

- ✓ Jacketing of overt portion of tunnel lining with the help of micro concrete and ribs.
- ✓ After completion of work, there is no further distress/deformation has been observed in the area.
