VISUAL INSPECTION AND ASSESSMENT OF OPERATING DEVICES IN IR. H. DJUANDA DAM - INDONESIA

RENI MAYASARI AND BUDI NUGRAHA

Jasa Tirta II Public Corporation, Purwakarta, Indonesia

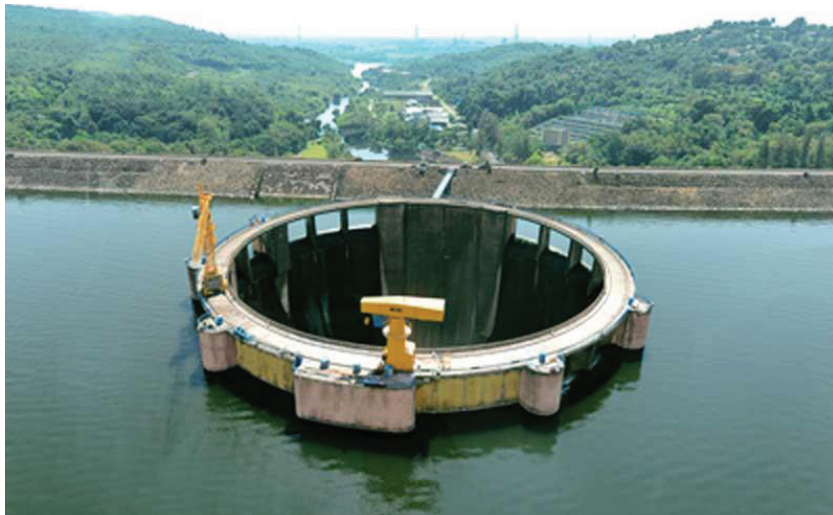
Figure 1 : Ir. H. Djuanda Dam

Located approximately 100 km southeast of Jakarta and 60 km northwest of Bandung, Ir. H. Djuanda dam is a new urugan dam with clay core, irin (Rock Fill with Inclined Clay Core). It has four saddle dam (saddle dam), namely the saddle dam of Pasir Gombang Barat, Pasir Gombang Timur, Ciganea, and Ubrug. The main spillway shaped tower type of morning glory, which at the bottom also functions as a powerhouse, as "Figure.1".

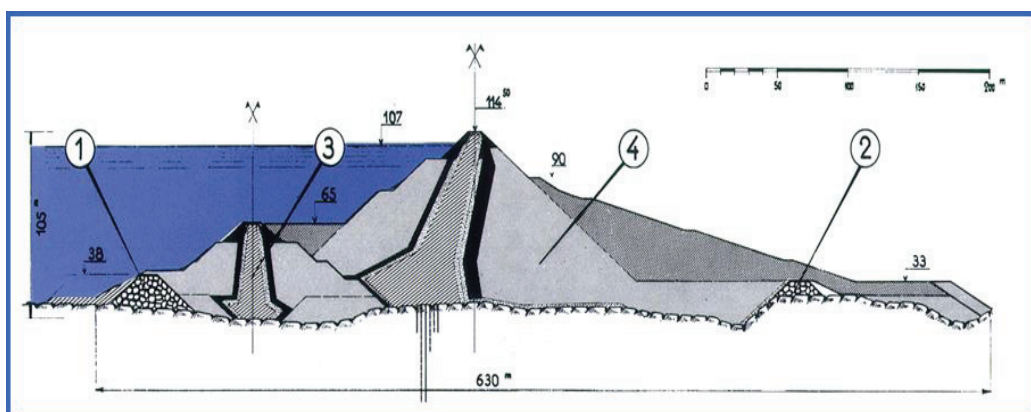
Figure 3 : cross Section of the main Dam Ir. H. Djuanda

To assist in the event of a shortage of supply from downstream through the power cord, two irrigation supply channels (hollow jet valve) are available on the eve of +49 m.dpl, see as “Figure 2 and Figure 3”. Based on the result of the year 2000, the volume of TMA +107 m.dpl (normal pool level) of 2.448 million m³ with the puddle area of 81.3 km². The dam was built in 1957 and completed in 1967 on the Citarum River, with a catchment area of 4,500 km², while the catchment area directly to the reservoir after the construction of Saguling and Cirata Dam in the upper reaches 380 km².
