ICOLD Symposium on Sustainable Development of Dams and River Basins, 24th - 27th February, 2021, New Delhi

IMPROVING DAM SURVEILLANCE AND MONITORING IN COUNTRIES WITH NON-EXISTENT LEGAL AND REGULATORY DAM SAFETY FRAMEWORKS – A CASE OF ISIMBA HYDROPOWER PLANT (UGANDA)

Uganda Electricity Generation Company Limited (UEGCL)

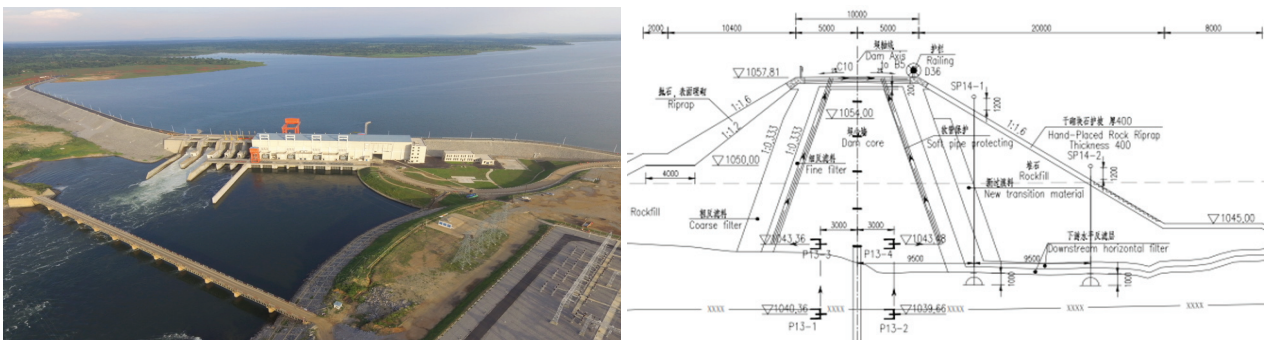
Figure 1 : An aerial view of Isimba Hydro Power Plant; Cross section view of Embankment Dam with installed instruments

The Isimba HPP is located about 50km downstream of the source of Victoria Nile River. It comprises of a 1.6 km long earth rockfill dam with a maximum height of 26.5m the details are in Table 1 below and the Aerial view of Isimba HPP complex is shown in Figure 1.

Unlike dams built in the previous years, Isimba dam was able to tap into the latest technological advancement and technical developments in design and construction. With 293 installed monitoring points, Isimba Dam ranks number one as the most monitored dam facility in operation within Uganda. The installed instruments include: piezometers, monuments, inclinometers, strain gauges, etc. Figure 1 shows cross section of Right Embankment and instruments installed at chainage D1+ 275.

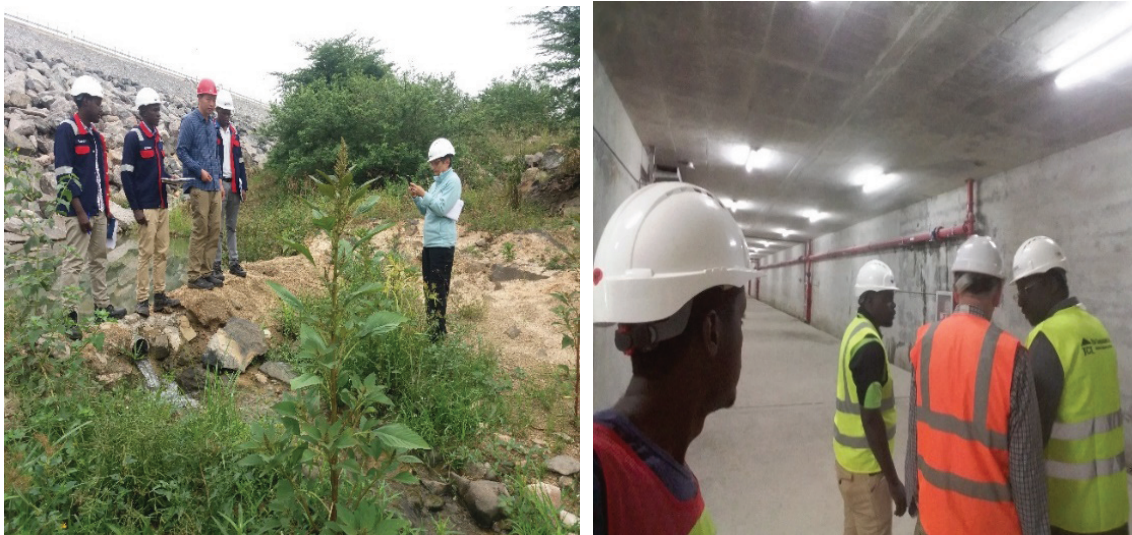
Figure 4 : Dam Engineering expert (POE) together with contractor and UEGCL staff inspecting a weir downstream of the dam (left);; hydraulic structures expert (POE) members at 1025 elevation gallery (right).

In April 2016 a panel of 7 members, also referred to as PoEs, with combined total professional experience of over 300 years in dam engineering was instituted by the client (UEGCL) to oversee construction of Isimba HPP, operation and maintenance as well as provide their professional experience. With their continued interface with the client, contractor and owner's engineer several recommendations have been put into consideration by the EPC contractor. Figure 4 shows pictorial evidence of PoEs at the dam during one of their site visits.
