MANAGING CHANGE AND OPTIMISING ASH STORAGE IN AN OPERATIONAL TAILINGS FACILITY

T.A. WILLIAMSON AND M. BARKER

GHD, Brisbane, Queensland, Australia

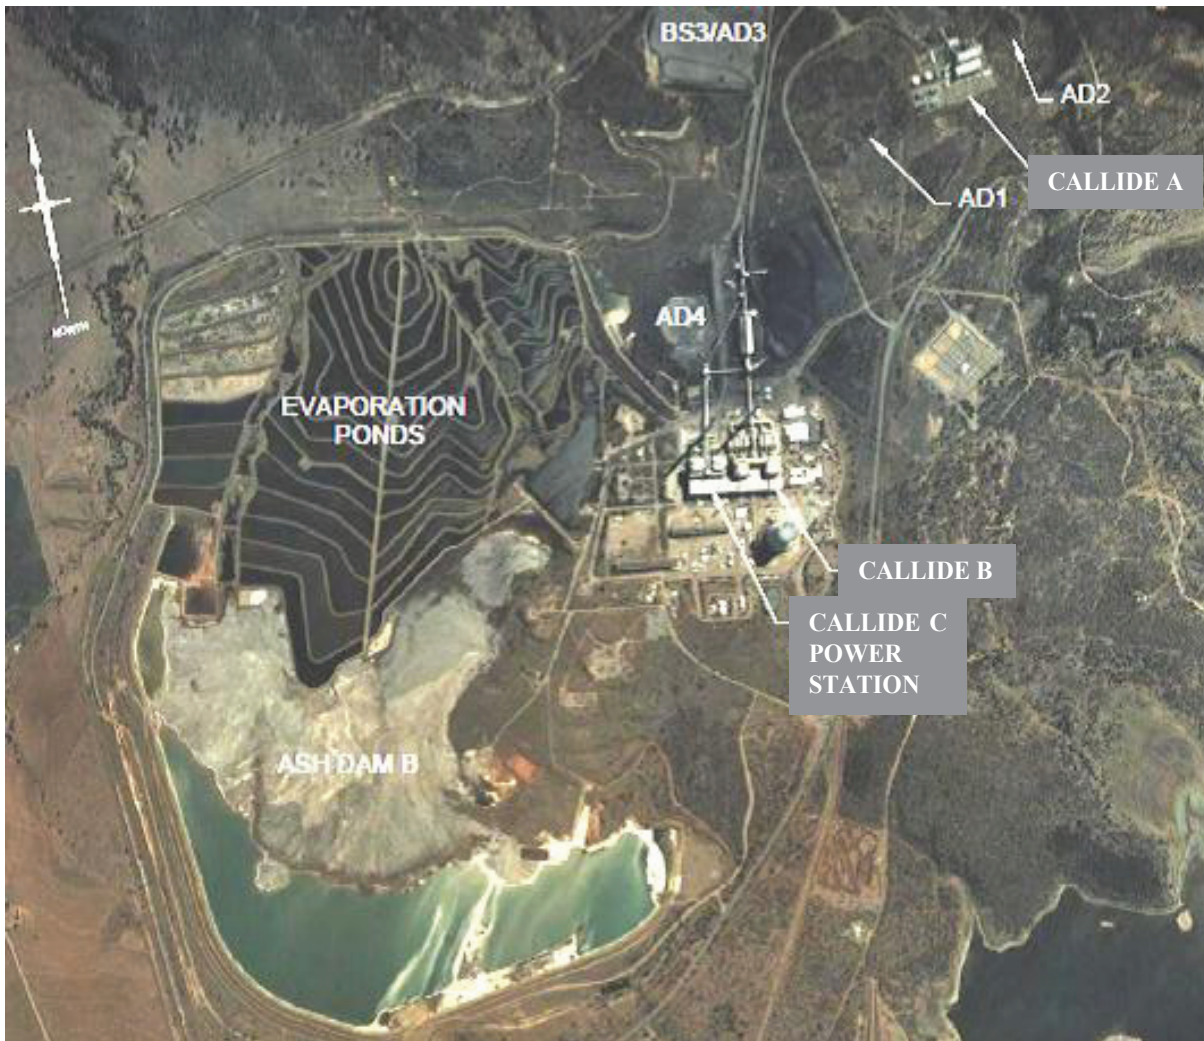
Figure 1 : Layout of Callide power stations and WCF.

CS Energy operates the Callide coal-fired power station facility that is located 18km north east of the rural township of Biloela located in the Banana Shire, Central Queensland in Australia. The site consists of three power stations, Callide A, Callide B and Callide C, and a waste containment facility (WCF), which contains multiple ash storage dams comprising Ash Dam 1 (AD1), Ash Dam 2 (AD2), Ash Dam 3 (AD3) (including a bottom boiler ash storage stockpile known as BS3), Ash Dam 4 (AD4) and Ash Dam B (ADB). The WCF also includes approximately 130 ha of evaporation ponds as part of the facility's water management system. The layout of the power stations, ash dams and evaporation ponds within the WCF is presented in Figure 1.

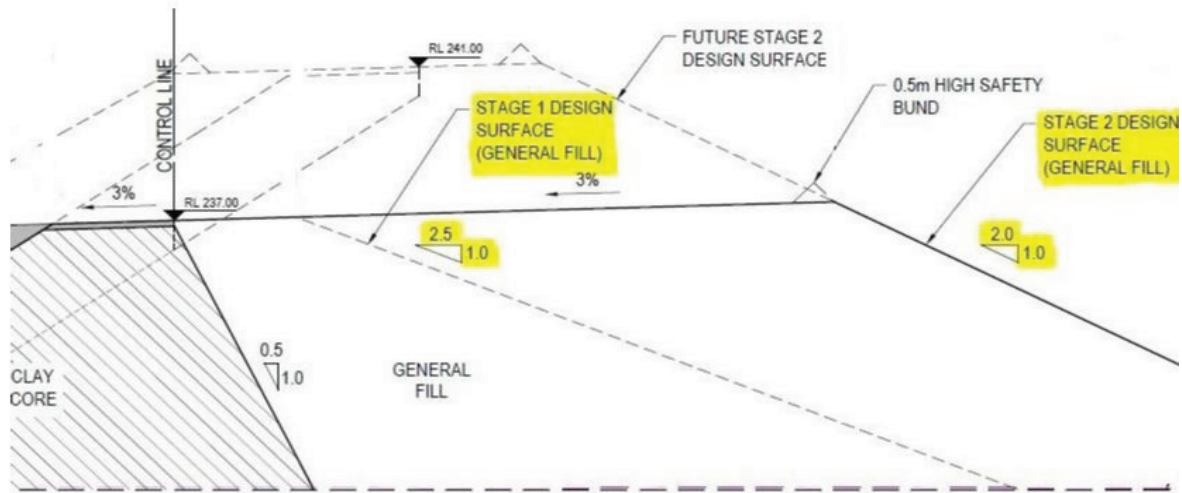
Figure 2 shows a section through the first dam known as Creek Dam 1 (CD1), which was planned to address the immediate ash storage issue. It was designed as a zoned earthfill embankment comprising the following zones and drainage:

Figure 2 : Optimizing the profile of the embankment dams.

- An upstream BBA zone with a permeability of 1E-4m/s to 1E-5m/s, designed to provide a high permeability layer to drain the water from any fresh ash deposition near the upstream face with the aim to lower the pore water pressure within the embankment and increase the overall stability. This was sourced from available stockpiles on site.

- The downstream shoulder comprised general fill, a gravelly clay to clayey gravel material, which was sourced from available weathered rocks on site.
- Water collected in the upstream BBA zone was designed to be removed using a Megaflo® drain in the lower part of the BBA connected to a 100 mm Class 18 PVC drainage pipe leading to the downstream side of the dam via an excavated channel through the foundation of the wall. The PVC pipe was fully encased within the core zone and part of the fill zone using flowable fill (cement stabilised sand) with a BBA zone downstream of the flowable fill for seepage and piping control along the flowable fill/foundation interface.

Another factor to consider was cost. With the lack of knowledge, the designers began with specifying a conservative downstream slope ratio of 1 vertical (V) to 2.5 horizontal (H), i.e. 1V:2.5H. However, as ground investigations were completed and results provided on foundation properties, the designers were able to refine the slopes to a steeper ratio of 1V:2.0H. A cost saving was found by incorporating a steeper downstream raise of 1V:2.0H over an earlier built embankment, which had a 1V:2.5H slope (see Figure 2).

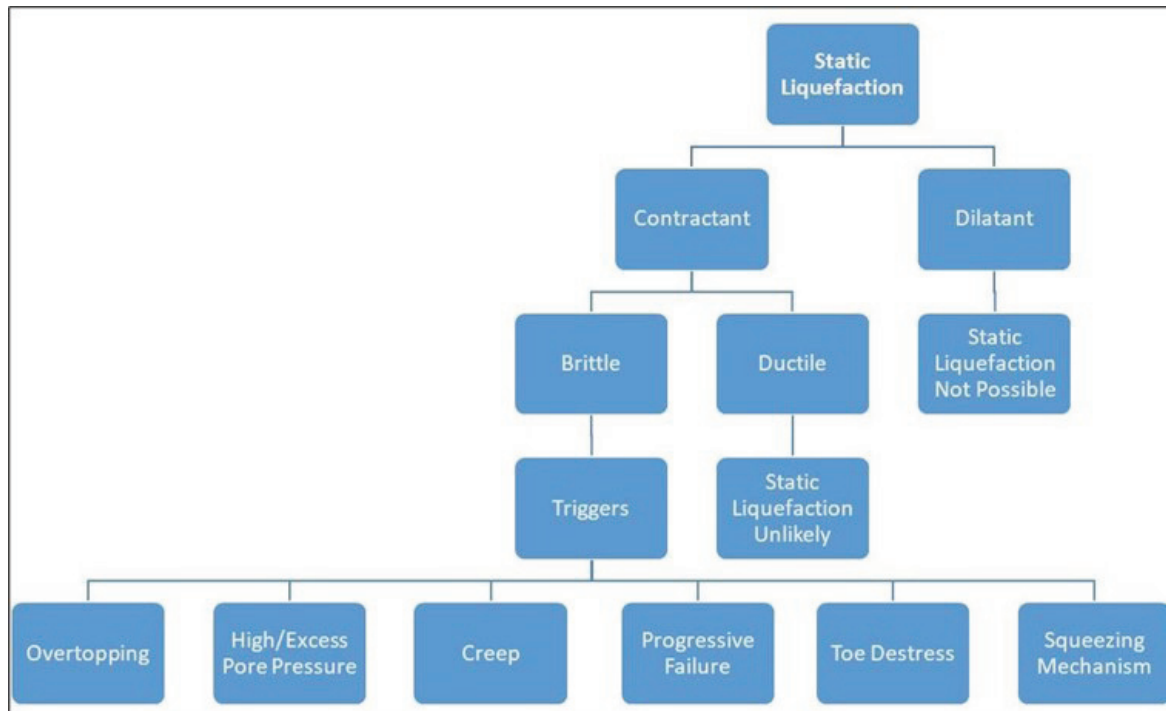
- Typical static liquefaction trigger mechanisms are depicted on Figure 3, include the following:
- Overtopping of the embankment leading to breach and release of the tailings through the breach, which increases shear stresses on the potentially liquefiable material.

- Squeezing mechanism postulated to be a trigger for the Fundão failure.
- An increase in the rate of loading through either constriction of internal bunds, an increase in ash production or rapid changes in water level in the ash deposit.

- Progressive failure/load shedding owing to differential movement within the foundation weak zone and the contractive brittle tailings.
- Ash slurry lean density and flushing cycles leading to excess free water and a high phreatic surface.

Figure 3 : Triggers for static liquefaction of a tailings storage facility (Barker et al. 2019).
