Best Practices Followed in Dam Safety Management & Governance Subansiri Lower Dam (2000 MW) NHPC Ltd

> Vipin Gupta, Executive Director Ramesh Ojha, General Manager Ram Kewal, Dy. Manager

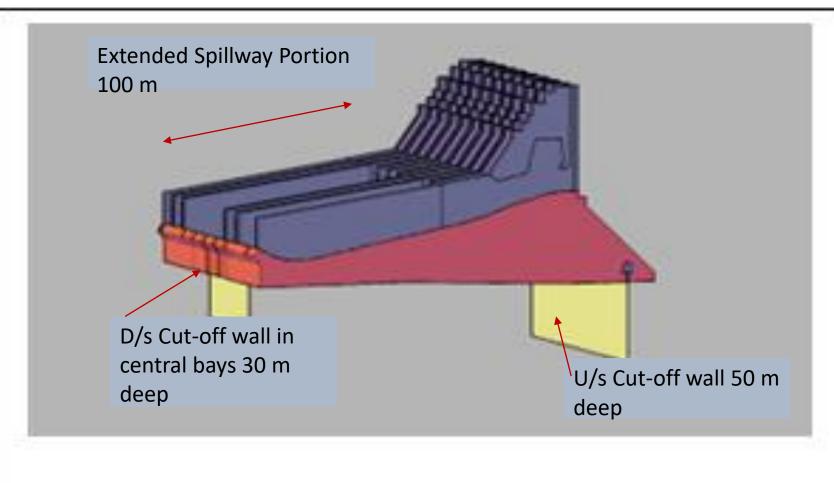
#### **Schematic view of Cut-off walls**

- To dissipate higher levels of water pressure at the dam foundation, due to seepage
- It is a cast-in-place wall, excavated under a supporting slurry (polymer) with reinforcement steel cages on the top portion.
- > Excavation was performed by **reverse circulation** method
- Cut off wall constructed using Trench Cutter into bedrock upto 50 m u/s of dam and 30 m d/s in extended dam
- M20 A20 Grade Concrete wall constructed panel by panel (primary and secondary)

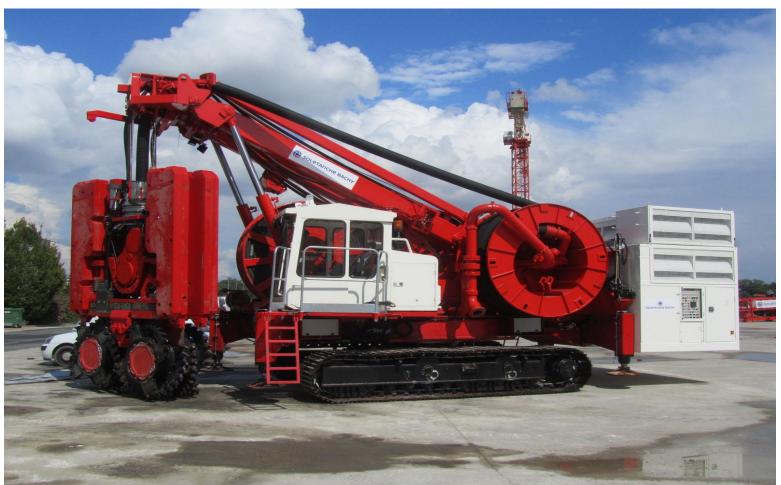
#### HC 05 HYDROFRAISE

- Executed by Solentanche Bachy, France through Hydrofraise Trench Cutter capable of cutting rocks of strengths well above 160Mpa
- 8 no. cut-off walls at different levels viz. EL 94m, 97 m, 120m (L), 120 m (R), 140 m, 155m, 173m and 185m have been executed
- Nominal width of cut off wall executed is 800mm and each cut-off wall is of 50 m depth at u/s and 30 m d/s
- $\succ$  The total executed area of cut off wall is approx. 18000m<sup>2</sup>
- > Time taken to complete the cut-off wall works was 28 months

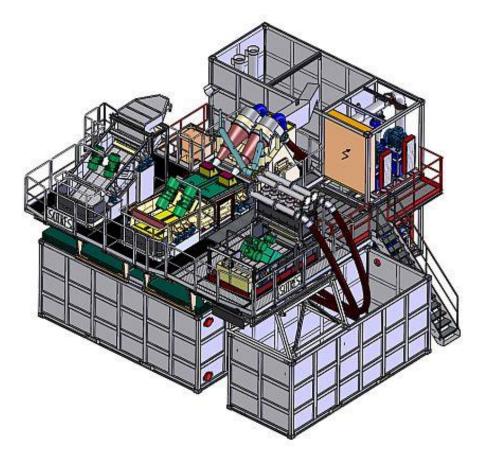
### **De-sanding Plant**

- Used to extract soil particles from drilling slurry (polymer)
- Fines generated from cutting was removed from slurry in de-sanding unit by system of sieves and centrifuges.
- Recycled slurry was reused

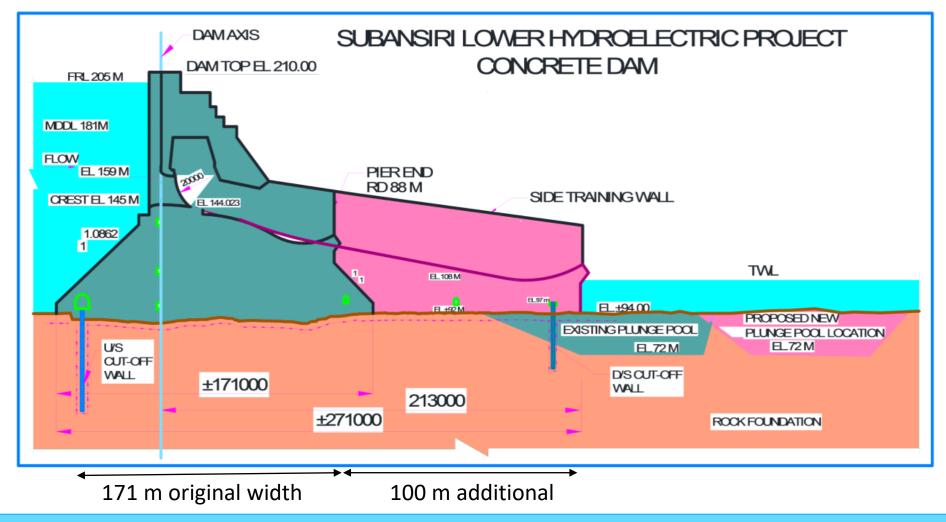
#### Additional Base width of Dam for Enhanced Safety

- The original base width of Dam was 171 m
- Additional base width of 100 m added in the form of Extended Dam
- The spillway bucket for central 4 bays (S4, S5, S6 and S7) and the remaining bays such as S3, S8 and S1, S2 and S9 have been placed at different elevations
- Minimized cutting as per the prevailing rock profiles at site was done to avoid cutting of the already stabilized rock cut slopes.
- The C/L of the new proposed plunge pool placed at distance of around 120m from the dam toe of extended section for the central 6 bays (S3 to S8) in the river valley

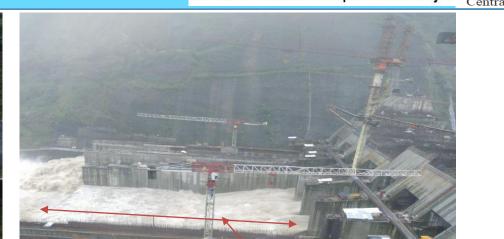
Front views of Dam under construction during two different seasons

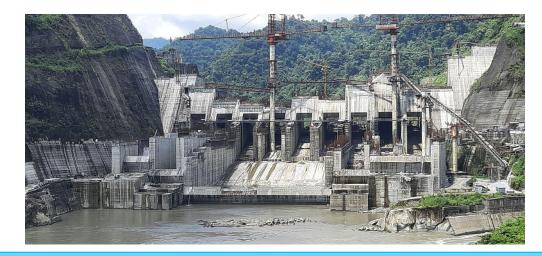
Side view of Dam showing additional base width

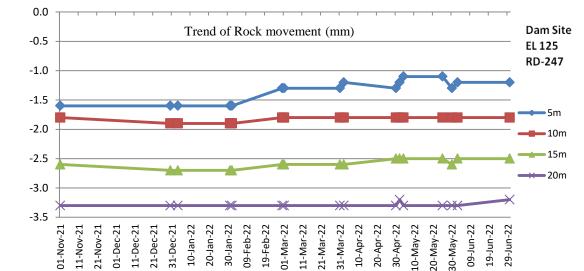
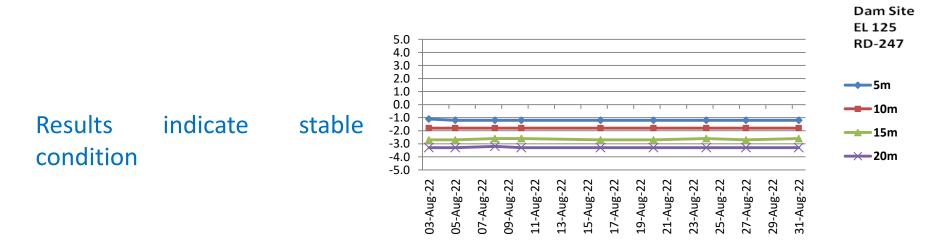
Comparison of observation of data to study any Rock Movement at same location in different periods

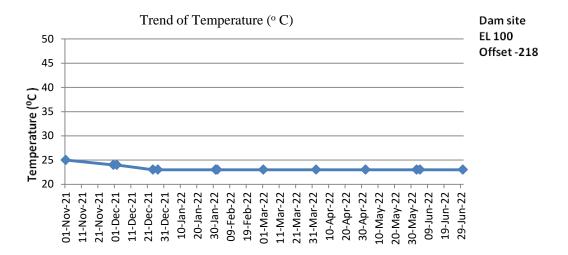
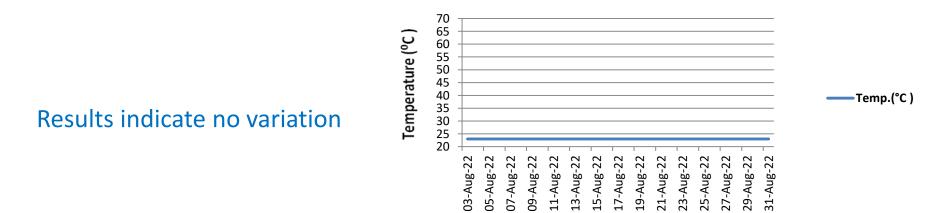
Trend of data of Temperature at same location in different periods

Trend of Temperature in (°C)

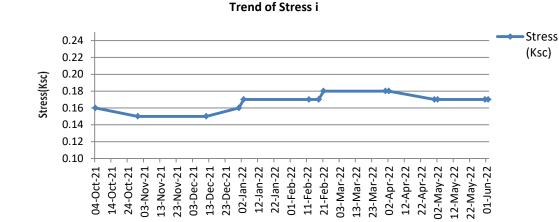
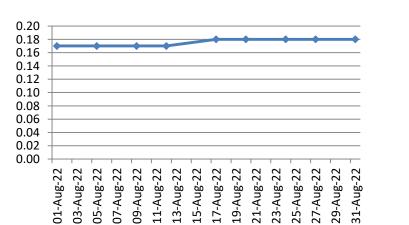
Trend of observed stresses in concrete surface in Dam body at same locations in different periods

**Trend of Stress**

Results are within permissible limits

Dam Site EL 123 RD 207

Stress ( Ksc)

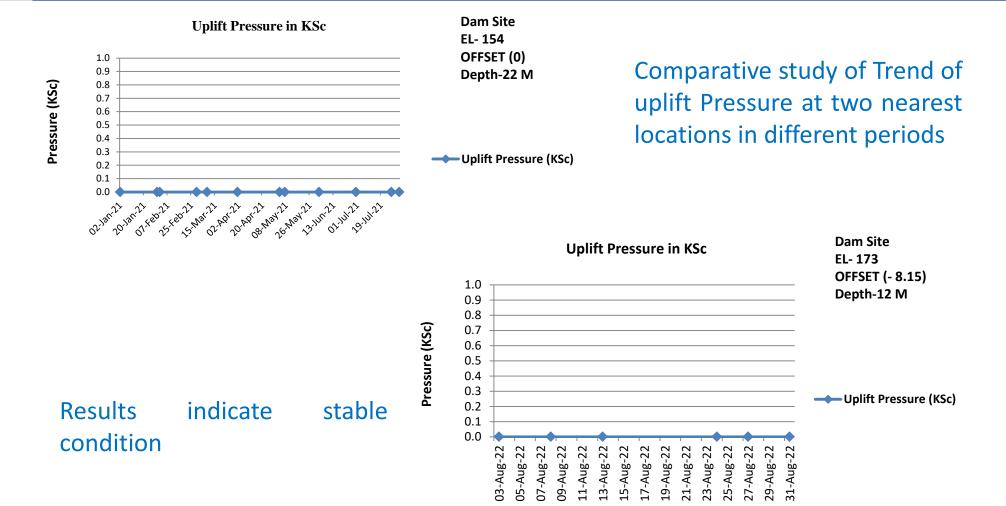
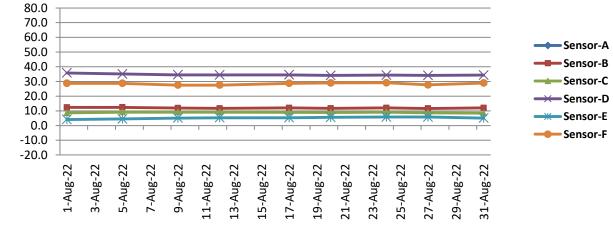
### Study ofStrainMeterobservationsduringAugust22

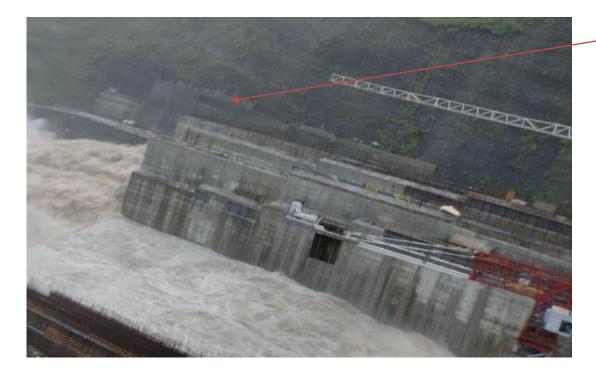
#### **Concrete cladding & Cable Anchors at Cut slopes**

Cut slope surfaces at d/s abutments on left and right sides is being provided with concrete cladding, cable anchors 35 m deep and grouted anchors for protection from rooster tail
