### Assessment and Management of Sedimentation in Kundah Reservoir – A Case study Presented by

V. Veeralakshmi, Executive Engineer, WRD,

State Project Management Unit, DRIP, Tamil Nadu

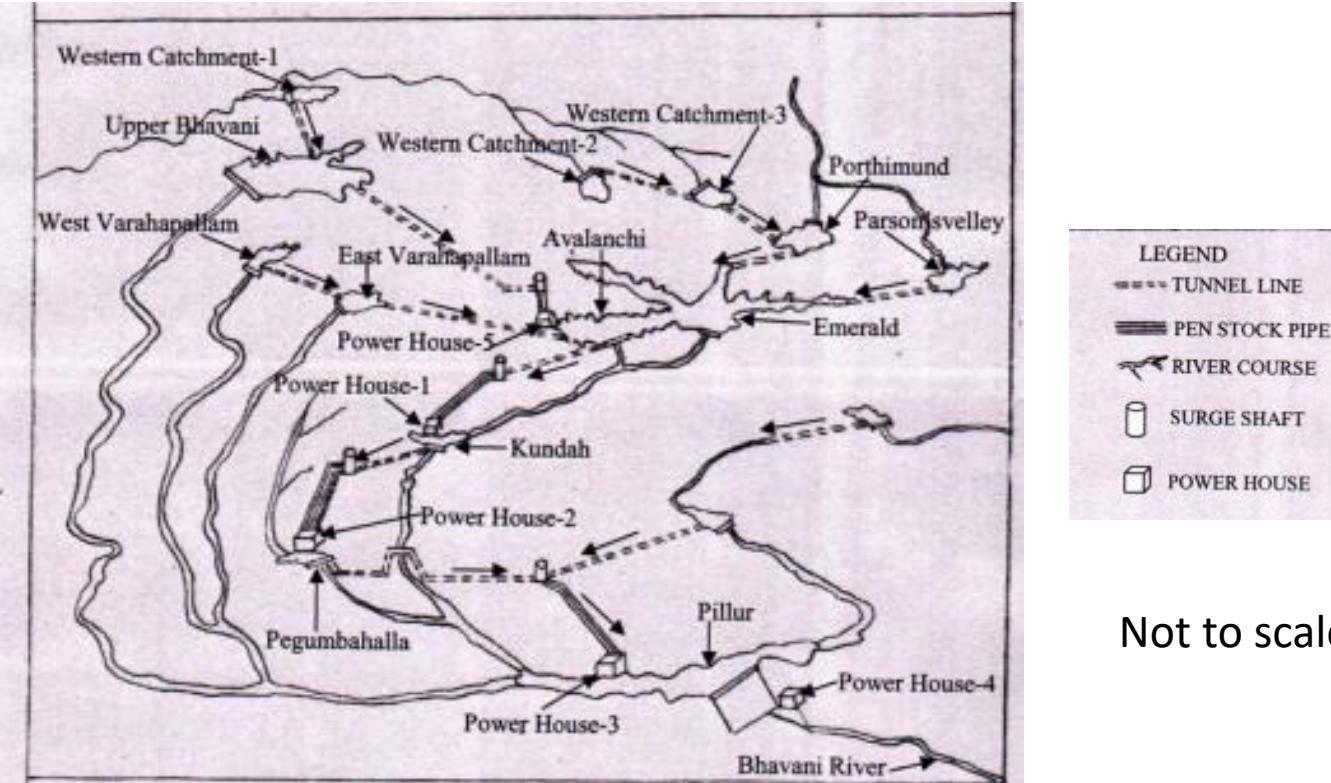
#### Flow Diagram of Kundah group of Reservoirs

- The Kundah Hydro-Electric project is the biggest Hydro-electric scheme in the state
- It consists of six reservoirs namely, Upper Bhavani, Emerald-Avalanchi, Parson's valley and Porthimund, Kundah, Pegumbahalla and Pillur.
- Kundah reservoir is one among the Kundah Hydro electric group of reservoir.
- The installed capacity of power house in Kundah is 175 MW
- It is situated in a fairly steep gorge near a place called Kundah Pallam in Nilgiris district
- The project area receives an annual rainfall of about 1400mm, distributed over 190-220 days,

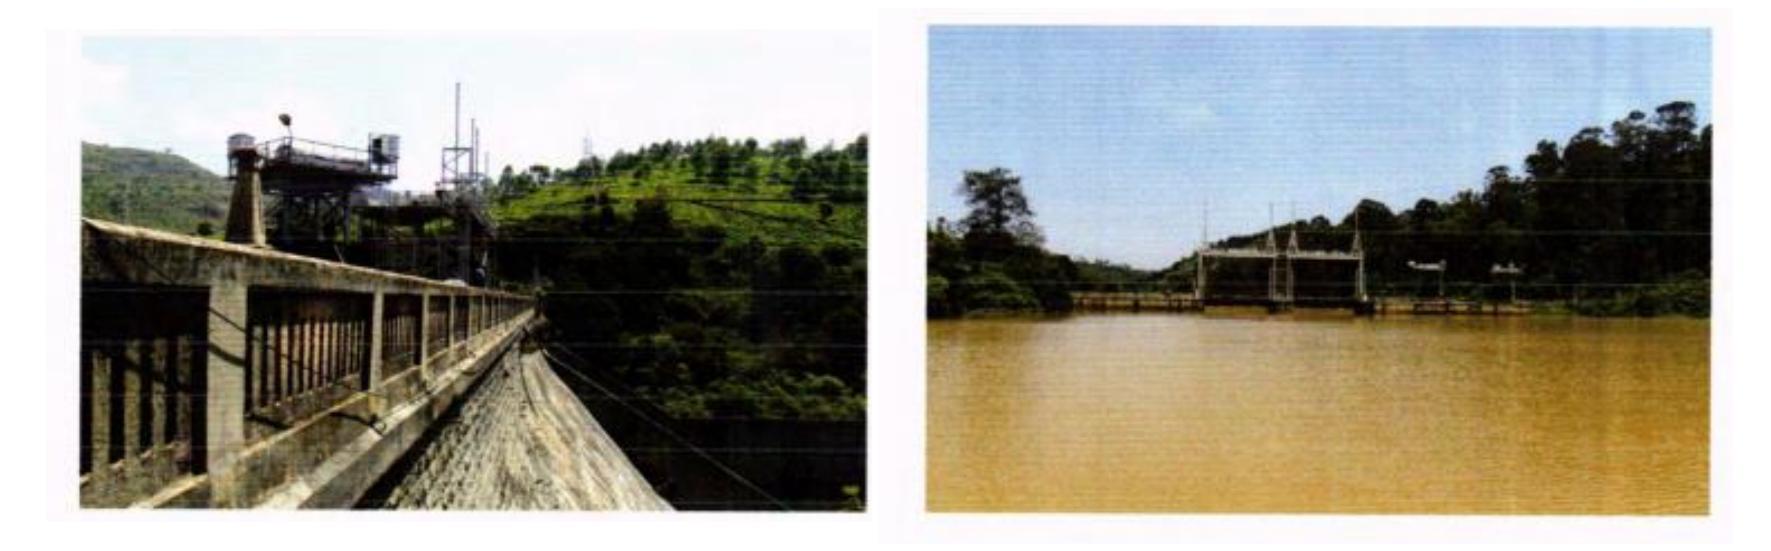
Kundah- Front view

Kundah- Rear view

• It is a straight masonry gravity dam constructed across Kundah river just below the Canada Power House No.1

Catchment area	:	113.96 Sq.km	F.R.L and M.W.L	:	+1625 m
Length of the dam	:	170.73 m	M.D.D.L	:	+1609.34 m
Height of the dam from deepest foundation	:	32 m	Scour vent sill Level	:	+1599.39 m
Top level of the dam	:	+1626.52 m	Deepest bed level	:	+1597.87 m
Top width of the dam	:	4.57 m	Spillway arrangements	:	2 lift type gates,
Gross capacity	:	1.76 M.cum	Spillway discharge	:	1556.5 cumec
Effective capacity	:	1.56 M.cum	Spillway gate size	;	12.2m x 9.14m
Water spread area at FRL	:	0.166 sq. km	Power house capacity	:	175 MW

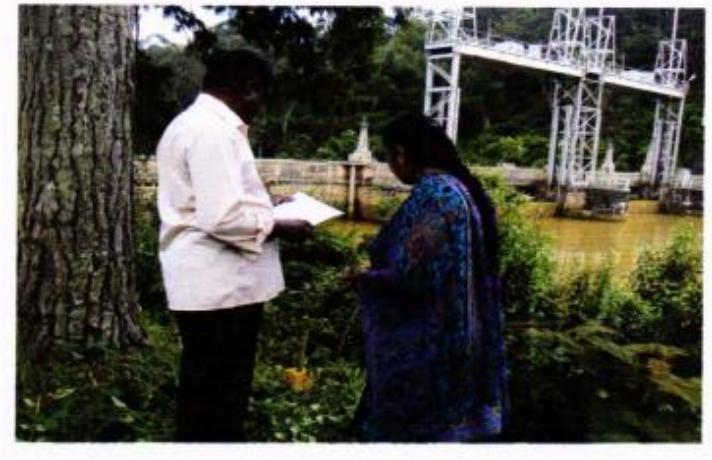
Fixing of range pillars

- 17 range lines were fixed & 34 range pillars were erected along the periphery of FRL line for triangulation survey by total station.
- Hydrographic survey has been conducted using BATHY 500 single beam Echo Sounder to measure the water depth and the present bed level was found out.
- The present water spread area map of Kundah reservoir was prepared in the scale of 1:4000 using the Surfer version 8 Software.
- This map has been used as the base map for developing the elevation – area – capacity relationship of Kundah reservoir and the present capacity of the reservoir was found out.

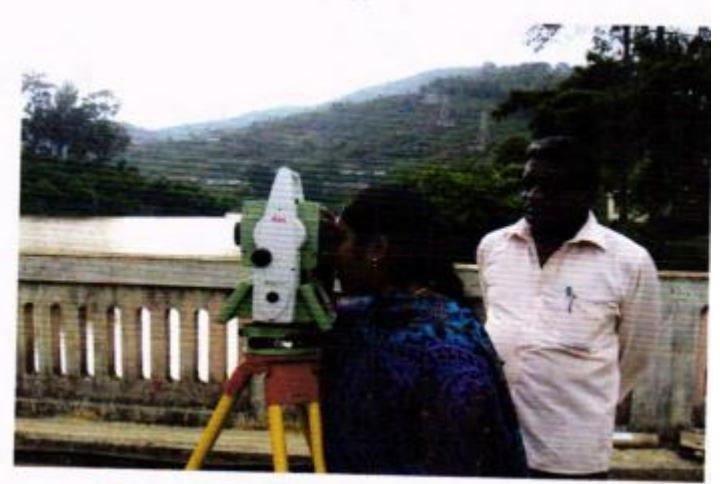
Triangulation survey network

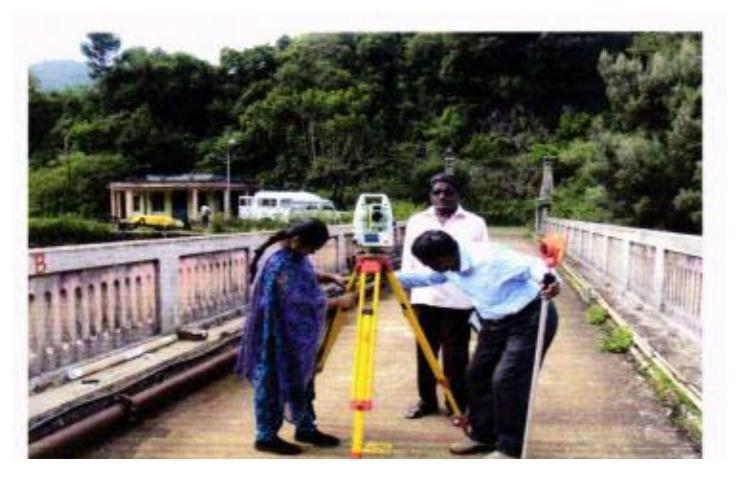
#### Triangulation survey- Baseline fixing

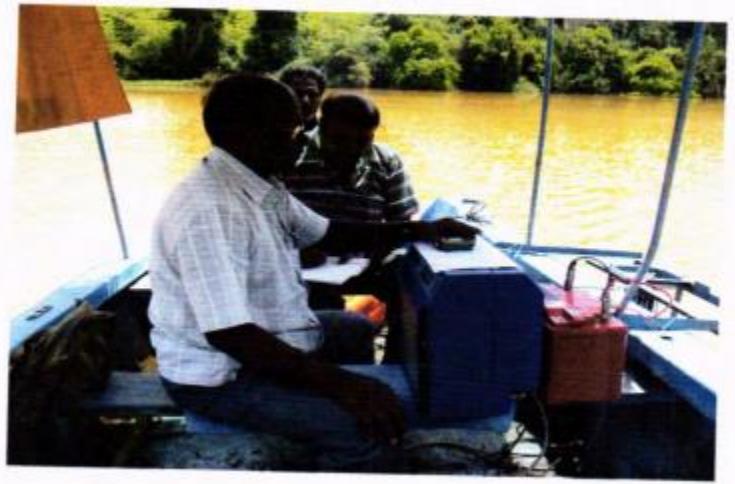
Hydrograhic survey

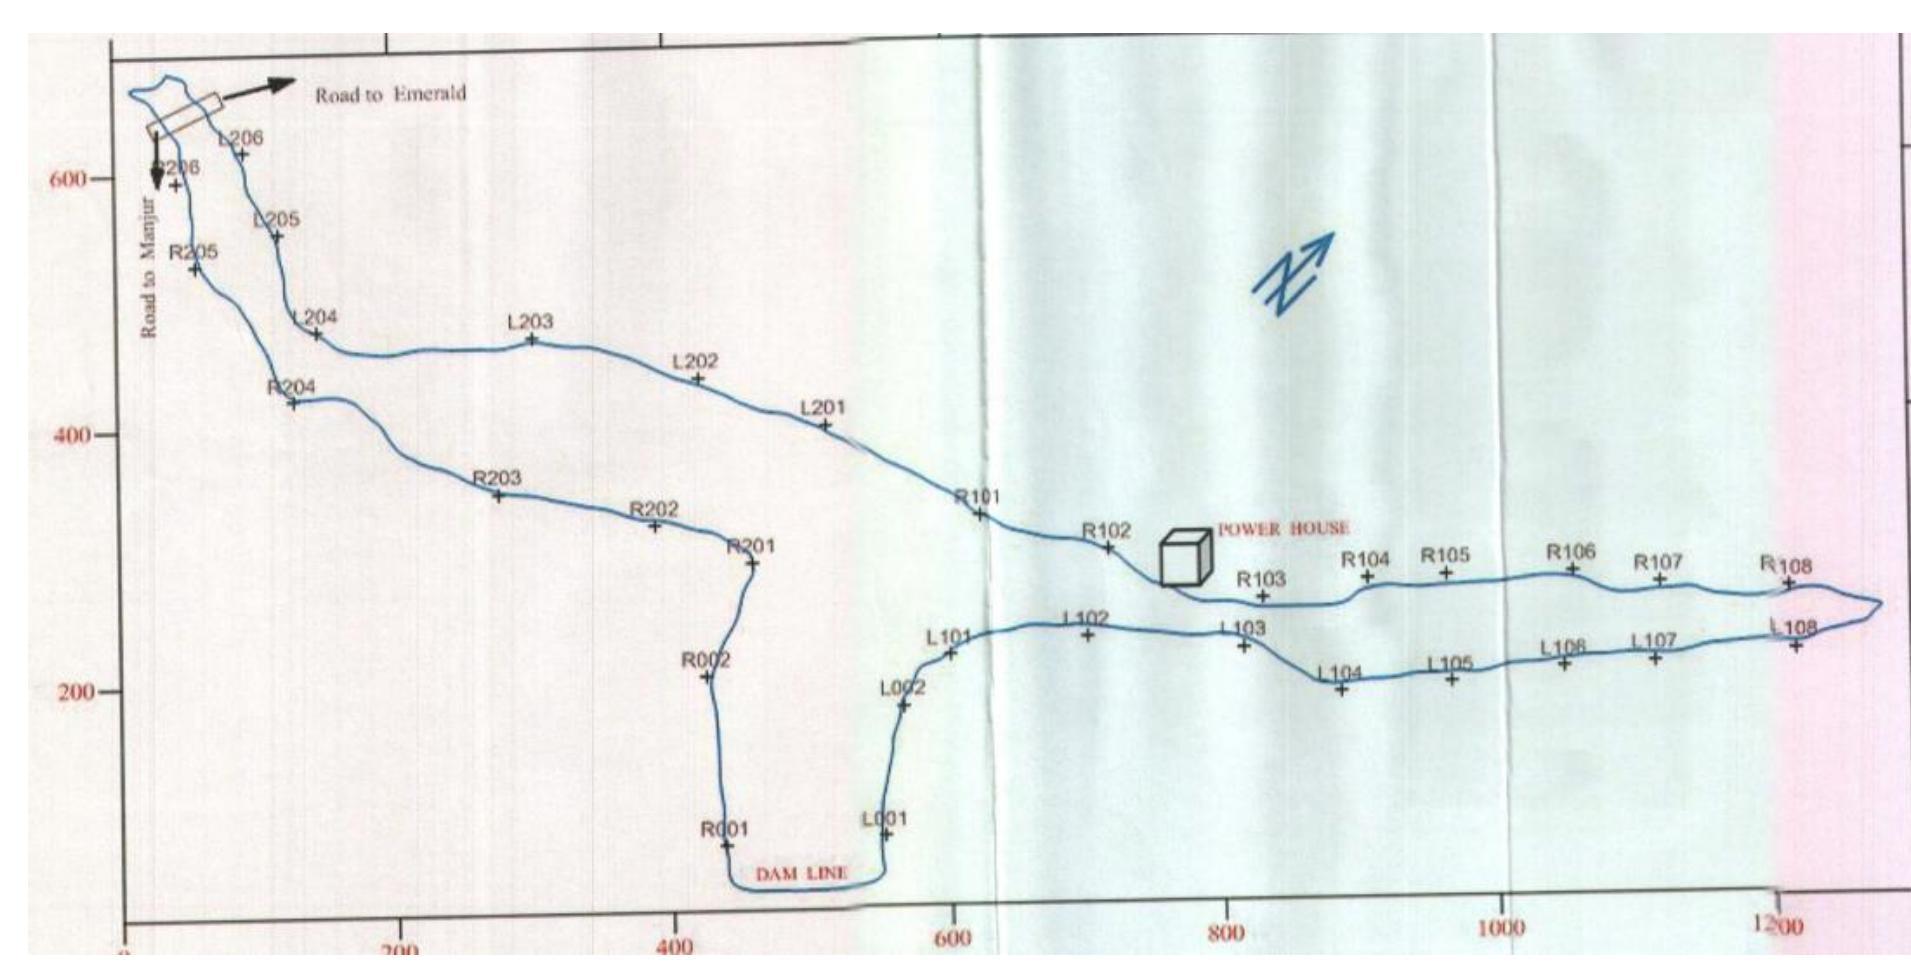
Water shed map showing the location of range pillars and power line

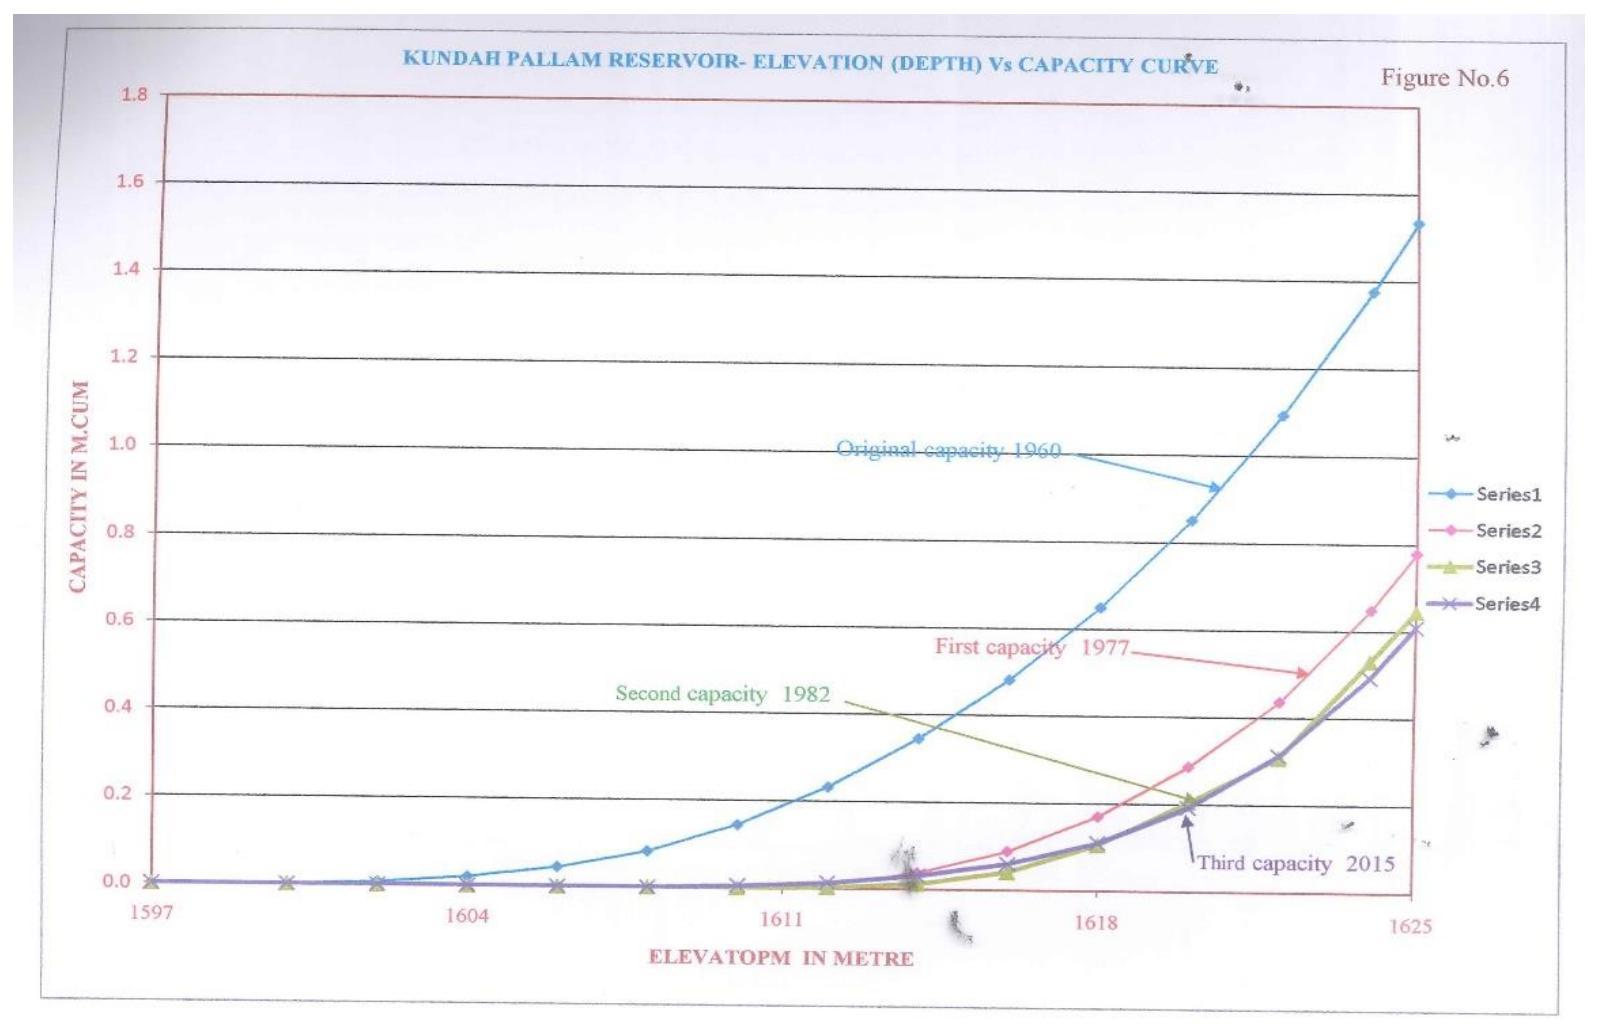
#### **ELEVATION VS CAPACITY**

- During the third capacity survey, the capacity of the reservoir increased up to the elevation +1618 m when compared that of second capacity survey and after the elevation +1618 m the capacity decreased.
- Totally, the capacity of the reservoir decreased by 0.036 M.cum when compared to second capacity survey and 0.924 Mcum when compared to the Original capacity of the reservoir, when the elevation is at FRL/MWL (i.e)+1625 m.

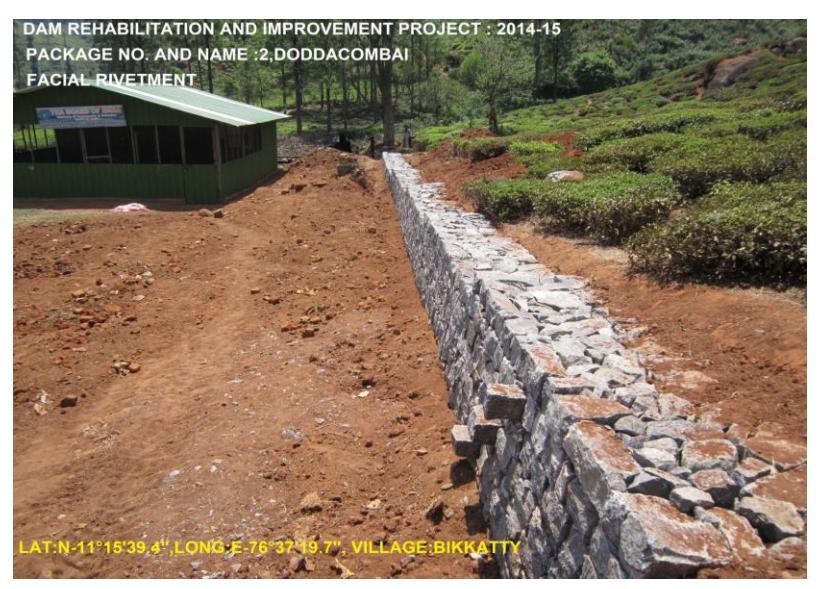
Terrace support wall / Facial revetment - To protect terraces soil slips, Terrace support wall / Facial Revetment for a length of 2950 mts was constructed in the agricultural field wherever necessary and along the cut face of the road, stream banks etc., in the catchment

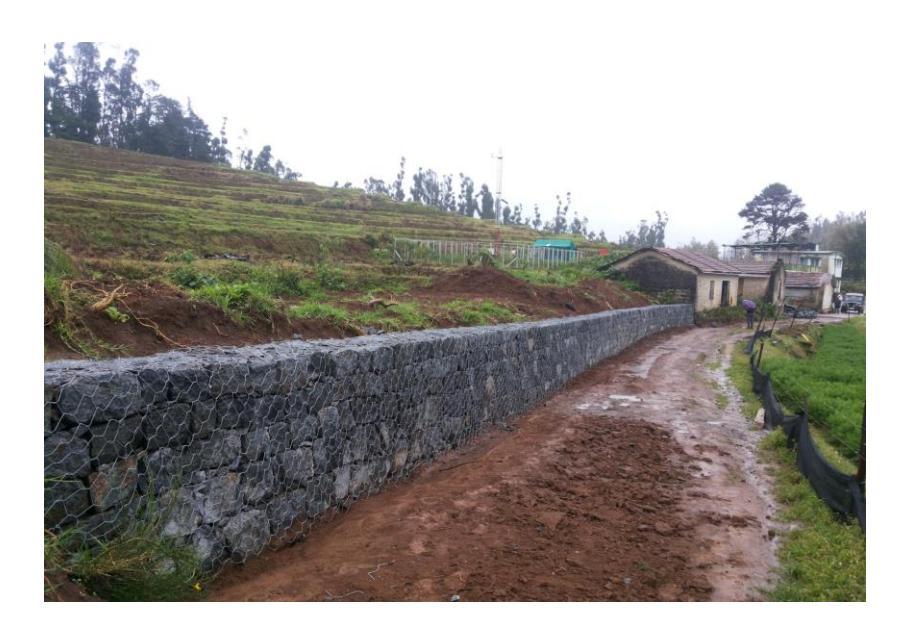
Gabion Terrace support wall / Gabion Facial revetment - To protect terraces soil slip, Gabion Terrace support walls / Gabion Facial revetment was constructed for a length of 1489 mts.

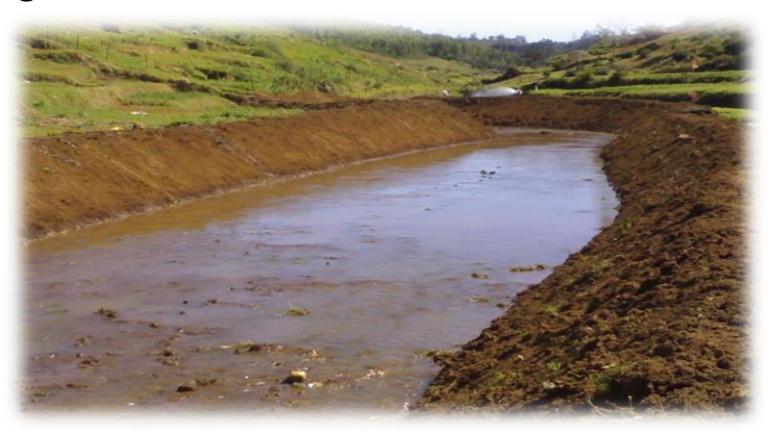
#### a) Channel alignment and Widening

The narrow river courses are to be widened in the lower reaches where the existing river beds are raised due to deposition of silt carried by the stream which result in flooding over nearby cultivated fields. It was proposed to deepen and widen of the streams to a length of 14948 m. in the catchment.

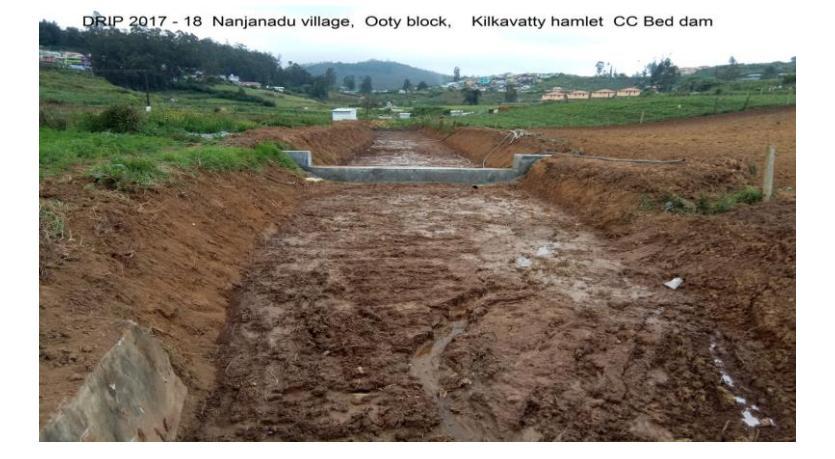
#### Bed Dam

The Bed dams are constructed in the lower reaches of gullies where ever the gullies have widened so as to impound the runoff water and to arrest the movement of silt.

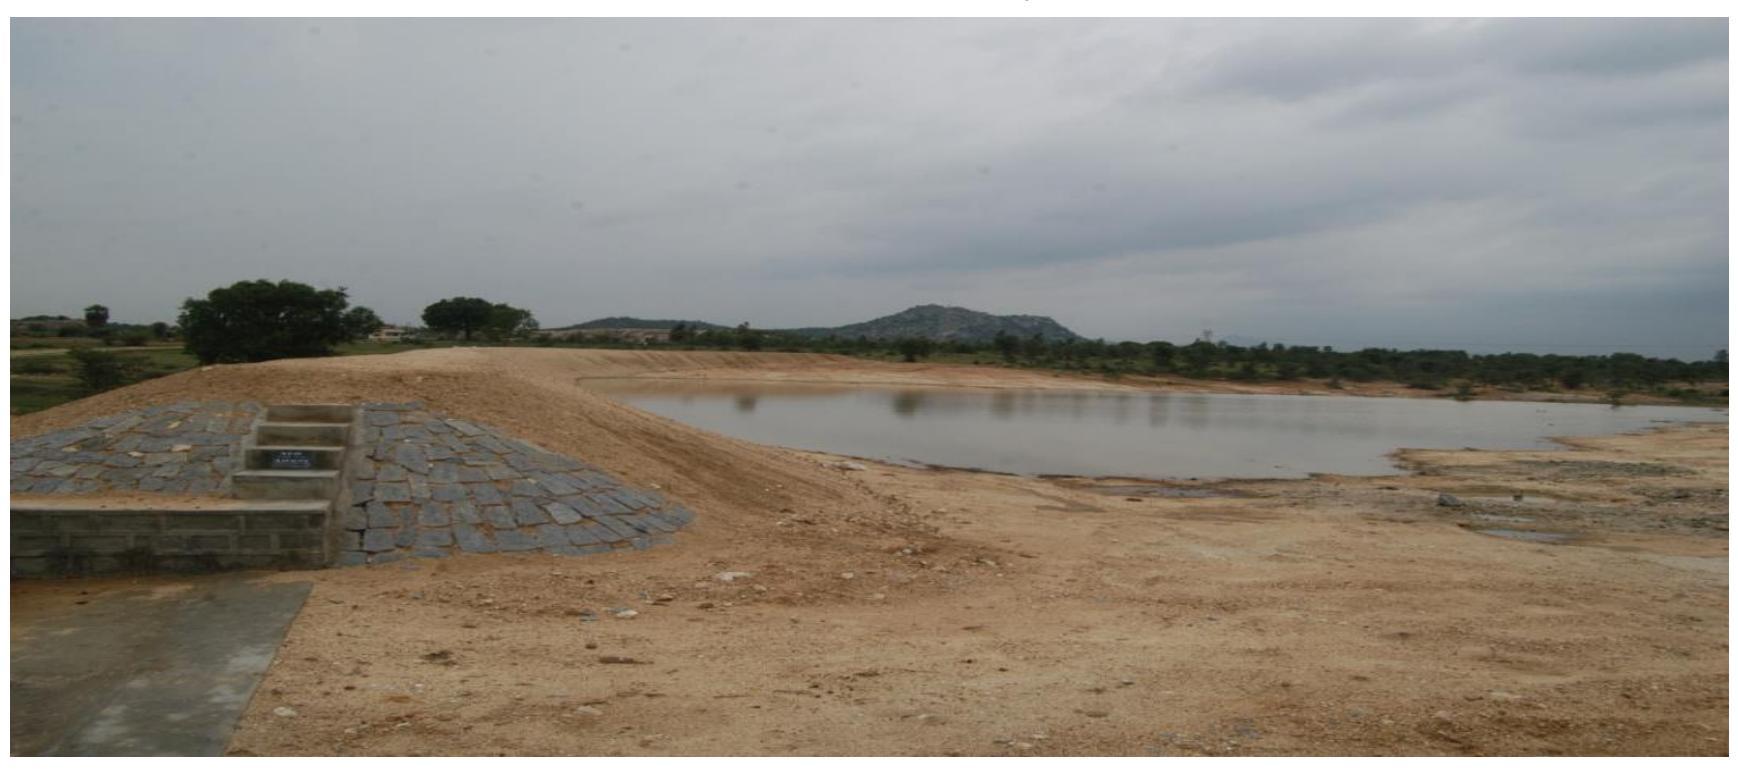
• During the flash floods large amount of silt is carried through the streams and is arrested by construction of silt detention structures. These structures help impounding the run off from the nearby field through streams and the farmers can also use the deposited silt in their fields as they are rich in nutrients

- No. of Silt Detention Tanks (SDT) constructed 45 Nos
- Quantity of Silt retained per SDT = 126.00 cu.m /filling/SDT
- Total No. of fillings per year = 4 Nos
- Total Quantity of Silt retained in all the SDTs per year
  = 126 x 4 x 45 = 22,680 cu.m/year
- Assuming Bulk density of sediment as 1.2 Tons/cu.m
- Water equivalent to the sediment is 27,216 Tons/year or 27,216 cu.m/year of water= 0.96 MCft.(0.027M.cum)
   Benefits of AED Interventions are:
- 22,680 cu.m/year of fertile top soil is prevented from erosion
- A quantity of 0.96 MCft water storage has been ensured for water filling by avoiding siltation

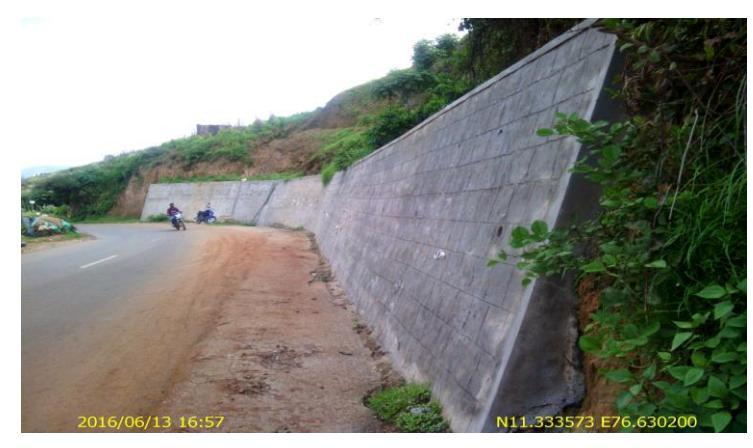
#### • Land slide Treatment works

Landslides are of frequent occurrence, due to the thickness of the weathered rocks and presence of steep hill slopes, the rate of soil creep and erosion is pronounced at places along the steep hill slopes, road sections and stream courses. Masonry structures were constructed to control landslides in the catchment

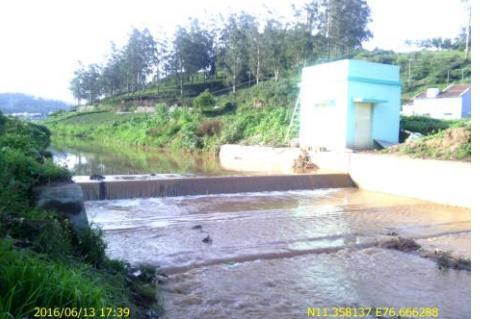
### • Silt Monitoring Station

The Silt Monitoring Station constructed across the gullies in the lower reaches of the micro watershed. These are Monitoring Stations to monitor the Silt content in the runoff which reflects the behaviour of the Watersheds over a period of time for varying rainfall runoff situations. Thus the Soil Loss/hectare/annum from the micro watershed could be computed. One silt monitoring station was constructed in Silla halla watershed.
